216 Church Road
Urmston
Manchester
M41 9DX
England
Tel/Fax: 0161 748 3644
Email: mail@rowantechnologies.co.uk
Web: www.rowantechnologies.co.uk

TECTON BUILDINGS (DUDLEY ZOO) (Long Term Monitoring of Like-for-Like Repairs - 2016)

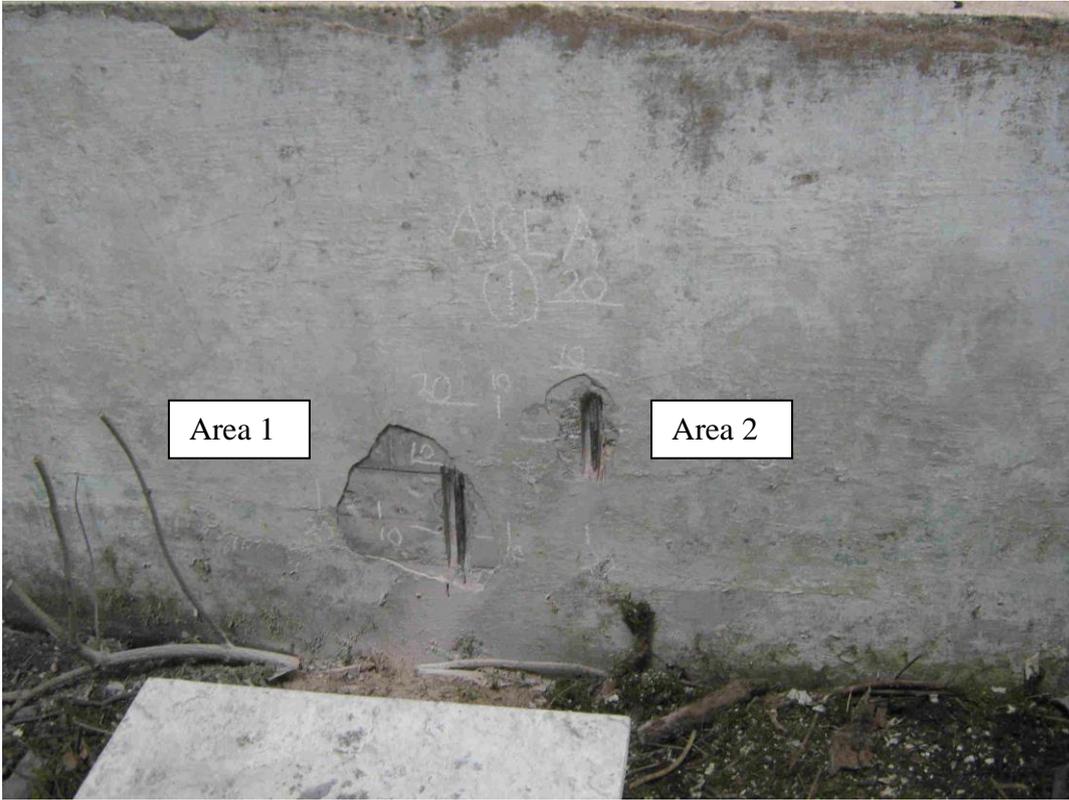
Location	Area 1	Area 2
1 Repair	22.0	12.6
2 Left - original	0.27	11.9
3 Right - original	1.41	0.86

Figure 1 Test areas 1 and 2 on the Bear Ravine.

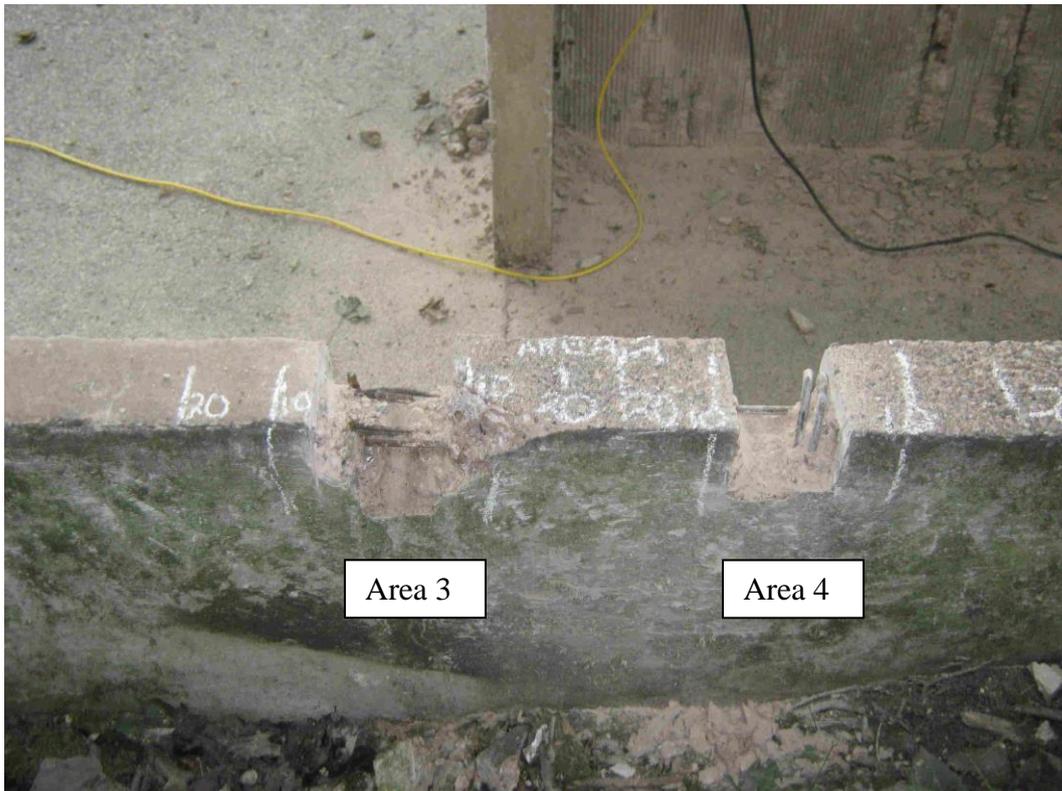
Location	Area 3	Area 4
1 back left on original	1.17	3.15
2 back centre under repair	6.06	0.16
3 back right on original	7.39	1.24
4 top left on original	20.5	20.9
5 top centre on repair	8.4	40.4
6 top right on original	9.29	17.2
7 front left on original	75.0	72.3
8 front centre on repair	24.1	73.1
9 front right on original	14.3	69.0

These results are significantly higher (approximately 5 to 10 times) than those taken in either 2014 or 2015 and this is almost certainly due to the increased moisture content in the concrete during this particular visit. Increased moisture can significantly increase corrosion rates on embedded steel if it is not protected by a passive oxide coating. As in previous reports, the higher corrosion rates were generally associated with the repaired areas, although sometimes the adjacent original concrete also showed higher levels of corrosion. During the repairs, the steel reinforcements were generally cleaned of their corrosion products (using a wire brush) and then coated using a zinc rich paint. This ‘barrier film’ might be responsible for delaying the formation of the protective oxide layer which normally forms on ‘cleaned steel’ in a highly alkaline environment. The original concrete would already have developed the protective stable oxide layer over the steel surfaces. Note – corrosion rates below $5\mu\text{m}/\text{yr}$ are generally regarded as being low and acceptable.

Figure 2 Test areas 3 and 4 on the Bear Ravine.

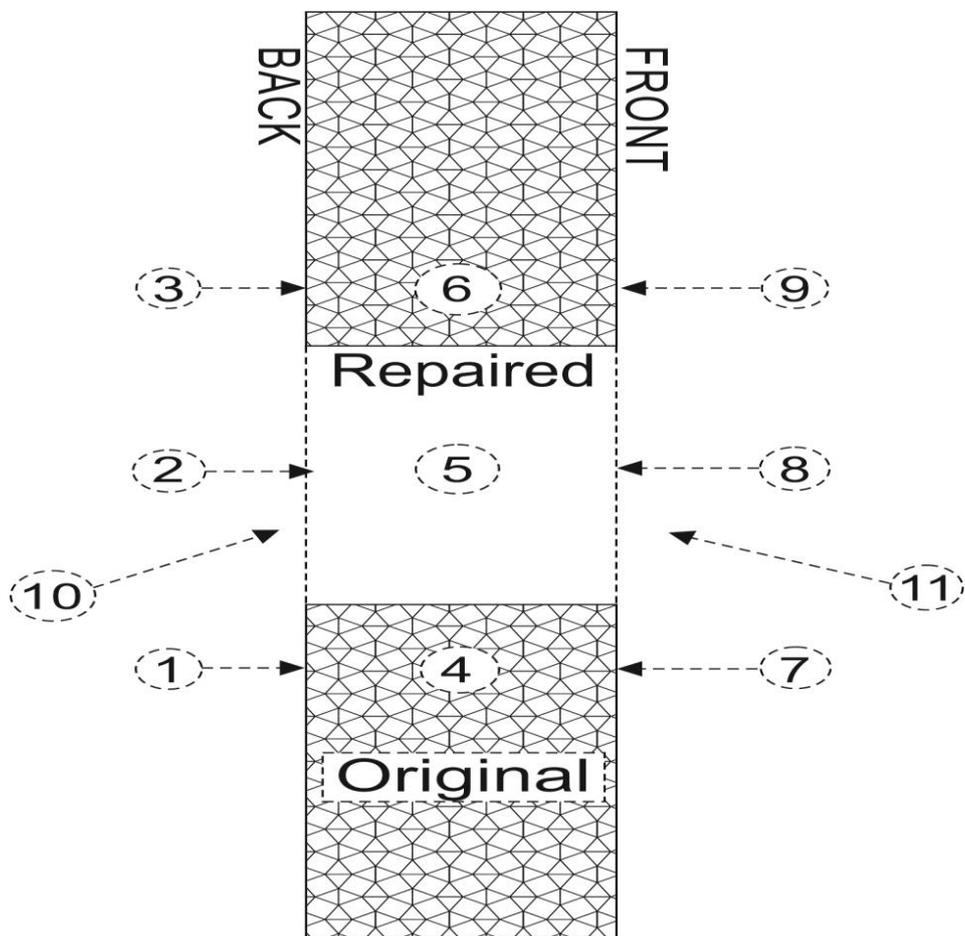
Figure 3 Locations where corrosion rate readings were taken in areas 3 and 4.

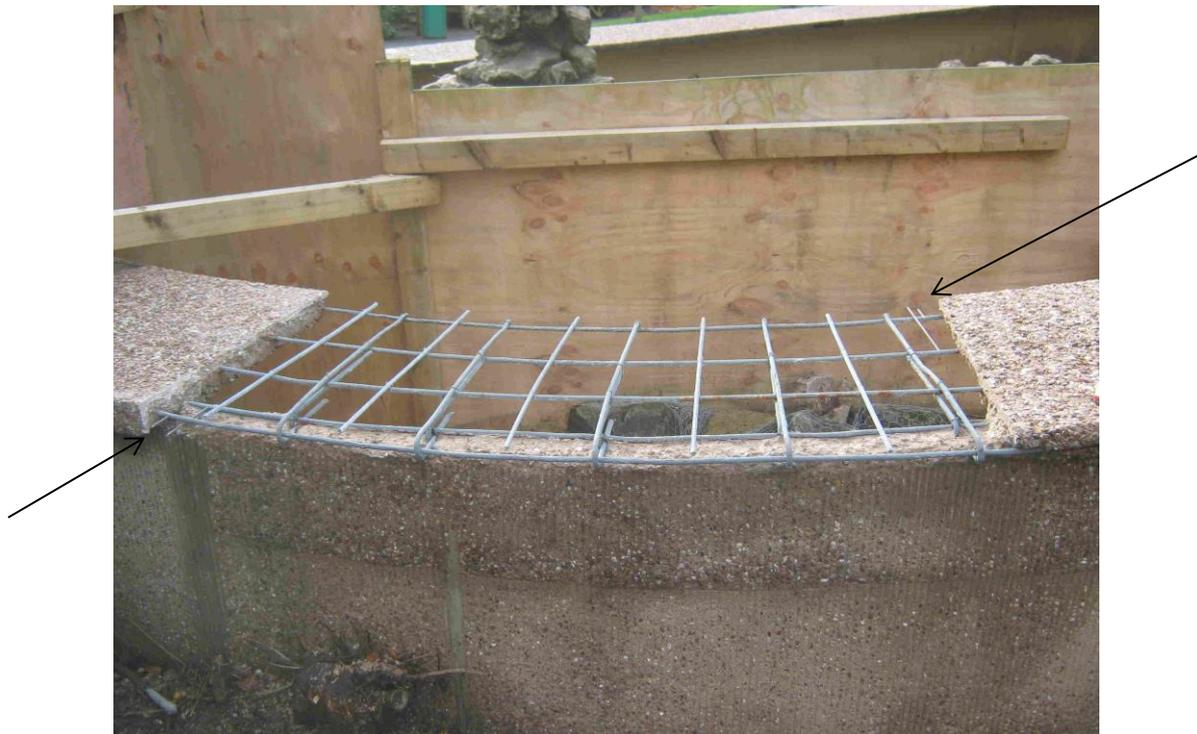
The repairs had now been fully completed on this structure. 4mm stainless steel threaded bars were mechanically attached to four of the existing steel reinforcements so that measurements could be taken both in the repaired and original concrete, Figure 4.

Figure 4 Broken out section at the back of the Meerkat Enclosure prior to repairs – showing the four stainless steel test points (right front and left back) attached to the rebars.

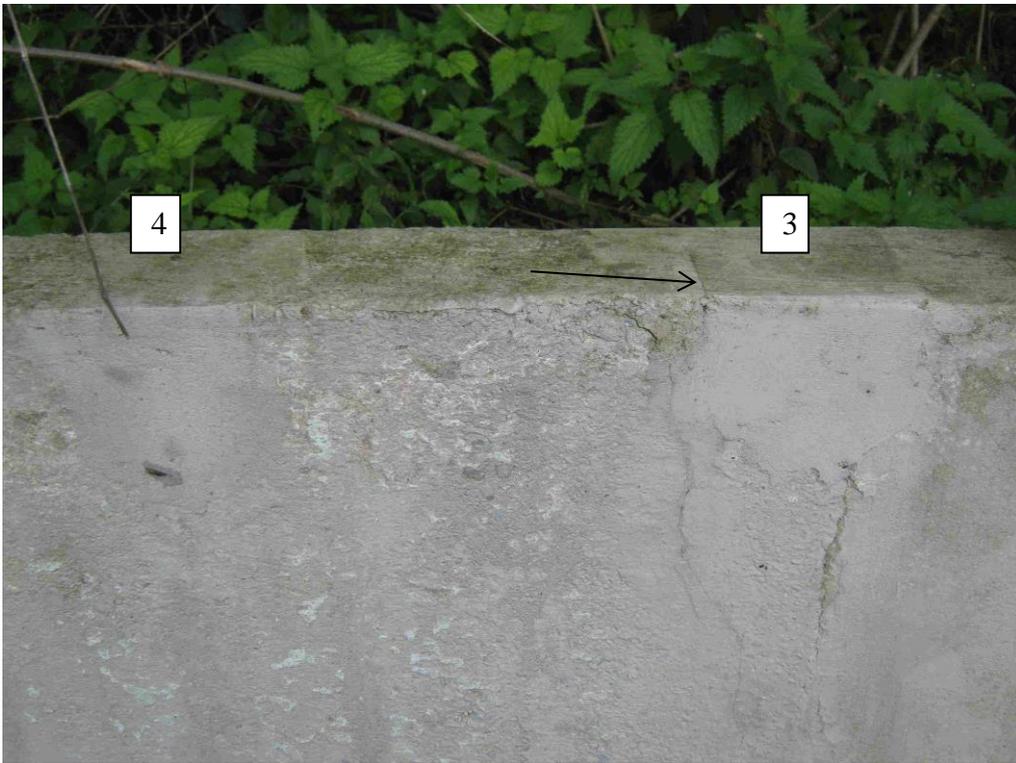
A brief assessment was made of the repaired areas of the concrete for both structures. The four areas that were monitored on the Bear Ravine showed that one of them (area 3) now displayed cracking on both the top and front surfaces of the two year old repair, Figure 5. The other repaired areas did not appear to have been effected. The cracks appeared to be due to shrinkage as the hammer survey showed no signs of delamination or spalling which would have indicated reinforcement corrosion. This particular repair had been hand applied using the proprietary repair material – Renderoc. The other three repairs had been hand applied using like-for-like materials.

Figure 5 Visual assessment of repaired areas 3 and 4 on Bear Ravine. Note area 3 (repaired with Renderoc) showing shrinkage. Area 4 (like-for-like) OK.

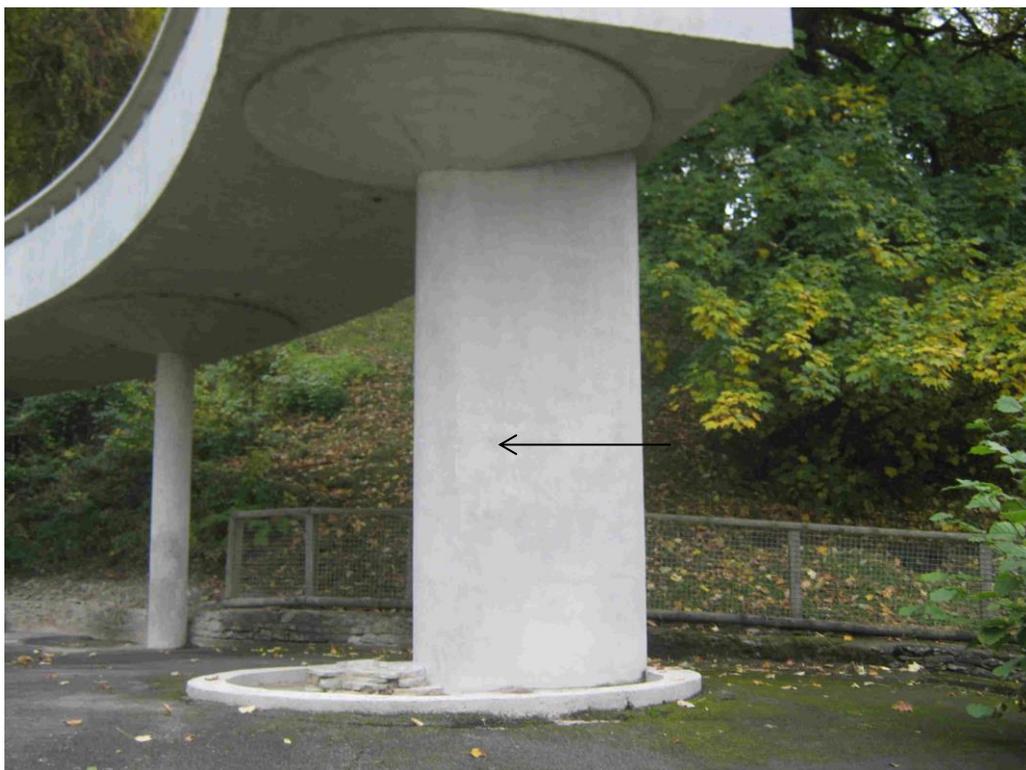
The main front pillar to the Bear Ravine showed a long vertical crack on its front face, Figure 6. This two year old repair was reportedly carried out using like-for-like materials and shutters to affect the repair. This needs more investigation. No signs of cracking were noted to the monitoring areas on the Meerkat Enclosure although these are currently less than one year old..

Figure 6 First pillar on Bear Ravine – showing vertical crack on repaired front face.
