## **TECTON BUILDINGS (DUDLEY ZOO)**

(Long Term Monitoring of Like-for-Like Repairs – Assessment in 2022)

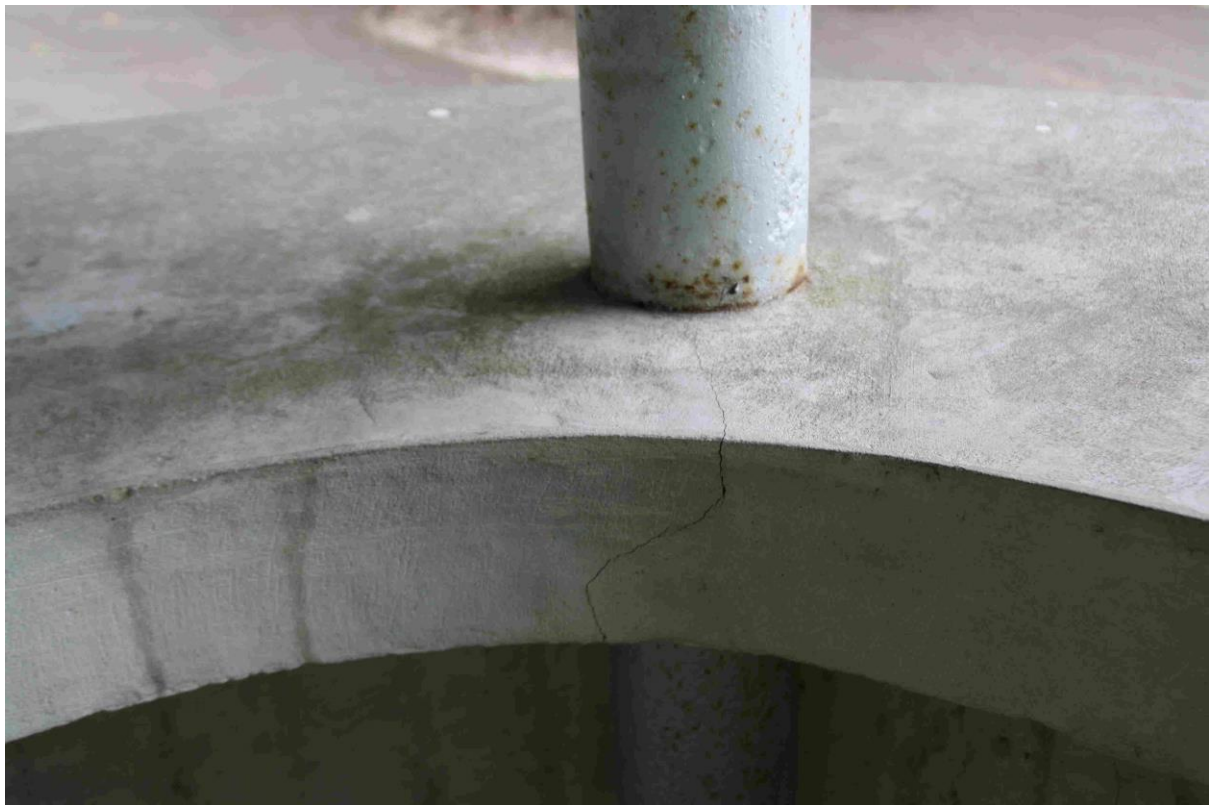
*Visual Assessment* – The kiosk was visually assessed. The repairs were still in an excellent condition and no significant cracking or delamination was noted in any of the repaired areas, Figure 1. There was a fine crack on the top counter to the kiosk leading out from a steel column, Figure 2. This had first been noticed in 2020 but it didn't appear to have increased in width. This is either a thermal movement crack (difference in thermal expansion of the steel and concrete) emanating out from the embedded steel post or possibly a small amount of ongoing corrosion of the 'embedded parts' of the steel column which is expanding and cracking the concrete counter.

Figure 2 Fine crack leading out from the steel column, possibly due to differences in thermal expansion between the steel and the concrete.

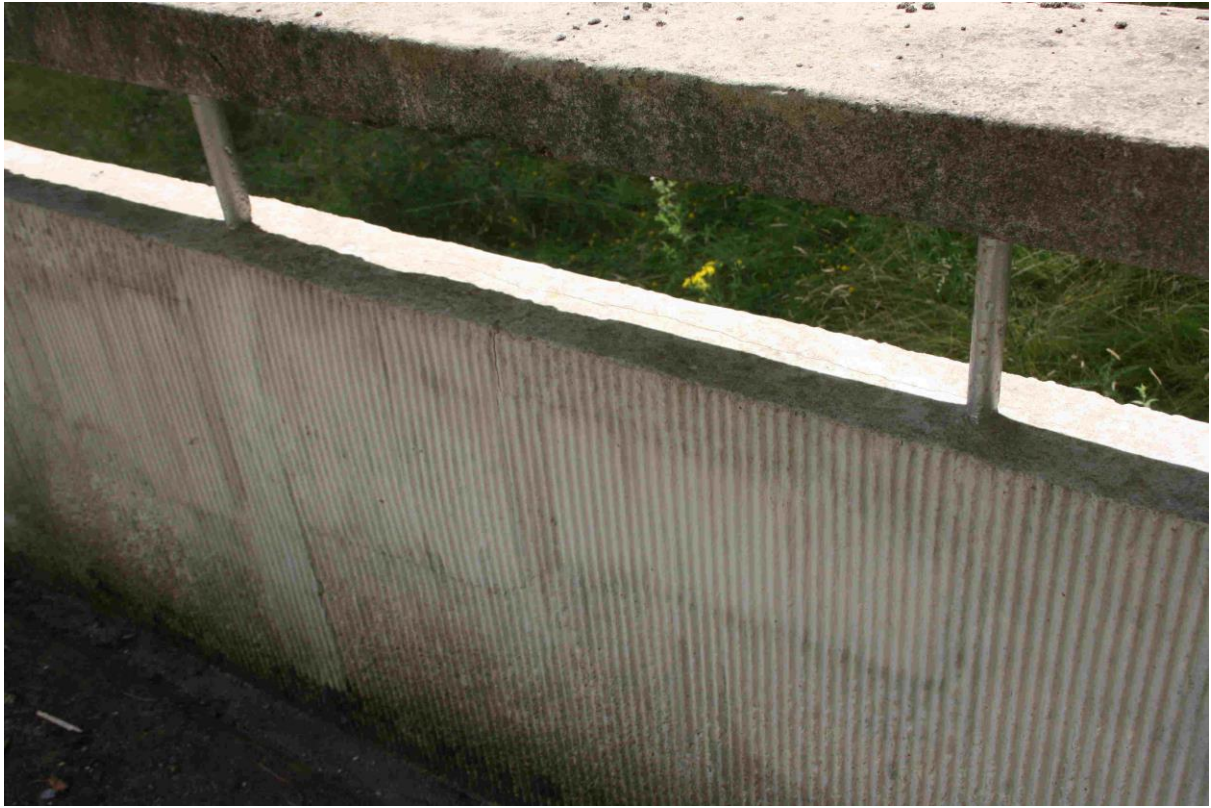
A number of cracks were noted to the central areas of the parapet wall to the prow of the Bear Ravine, Figures 4 and 5. Cracks were also noted to repair patches to the fluted section of the ground and first floor parapet walls, Figure 6. Some of these defects had first been seen in 2020 but the cracks now appear to be increasing in width and becoming more extensive.

Figure 5 Another crack noted to a repaired parapet wall to the Bear Ravine.

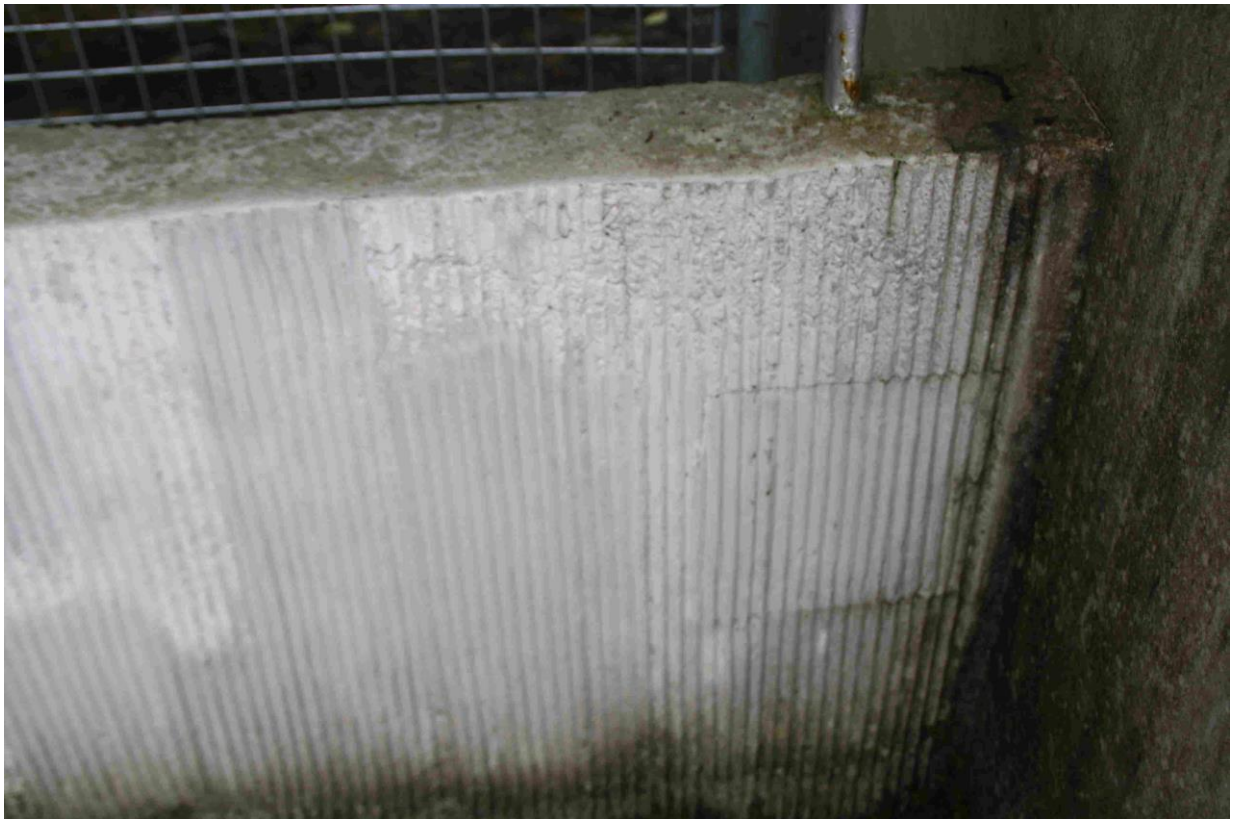
Figure 6 Classic shrinkage cracks noted around a square repair to the fluted section of the 1<sup>st</sup> floor wall.

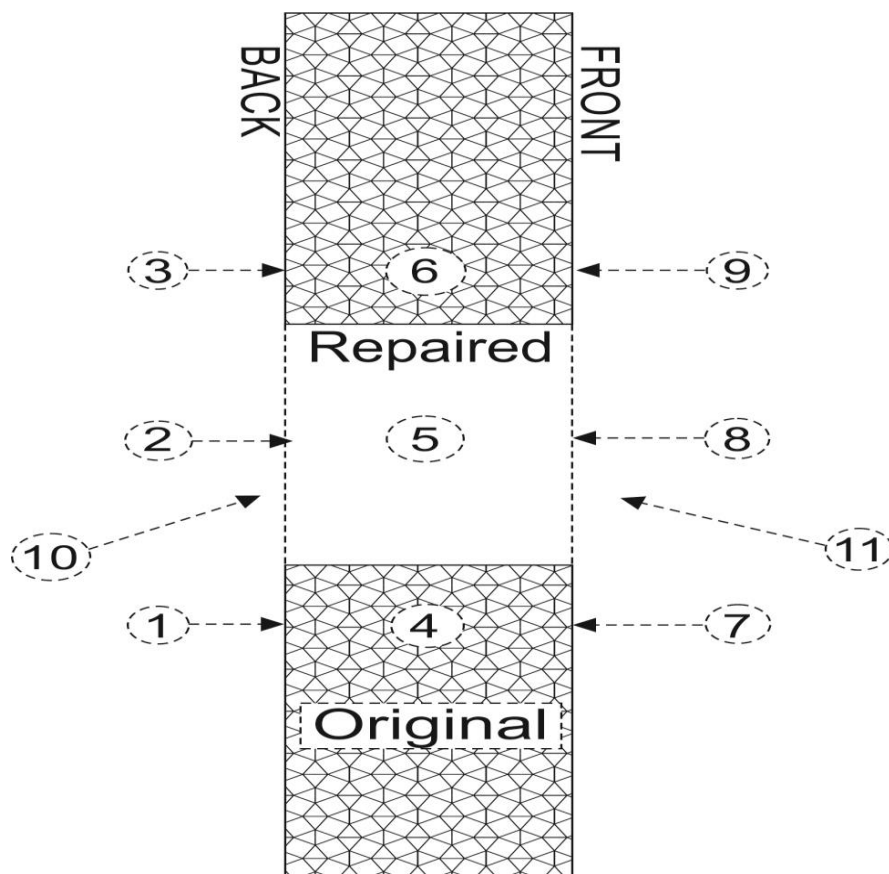
*Corrosion Rate Measurements*- Corrosion rate measurements were taken of the embedded steel reinforcements within, and around, the four test areas in both the new and original concrete on the Bear Ravine. A schematic of the test areas at test sites 3 and 4 shows where the measurements were made, Figure 9.

Figure 9 Locations where corrosion rate readings were taken in test areas 3 and 4 of the Bear Ravine 1<sup>st</sup> floor wall.

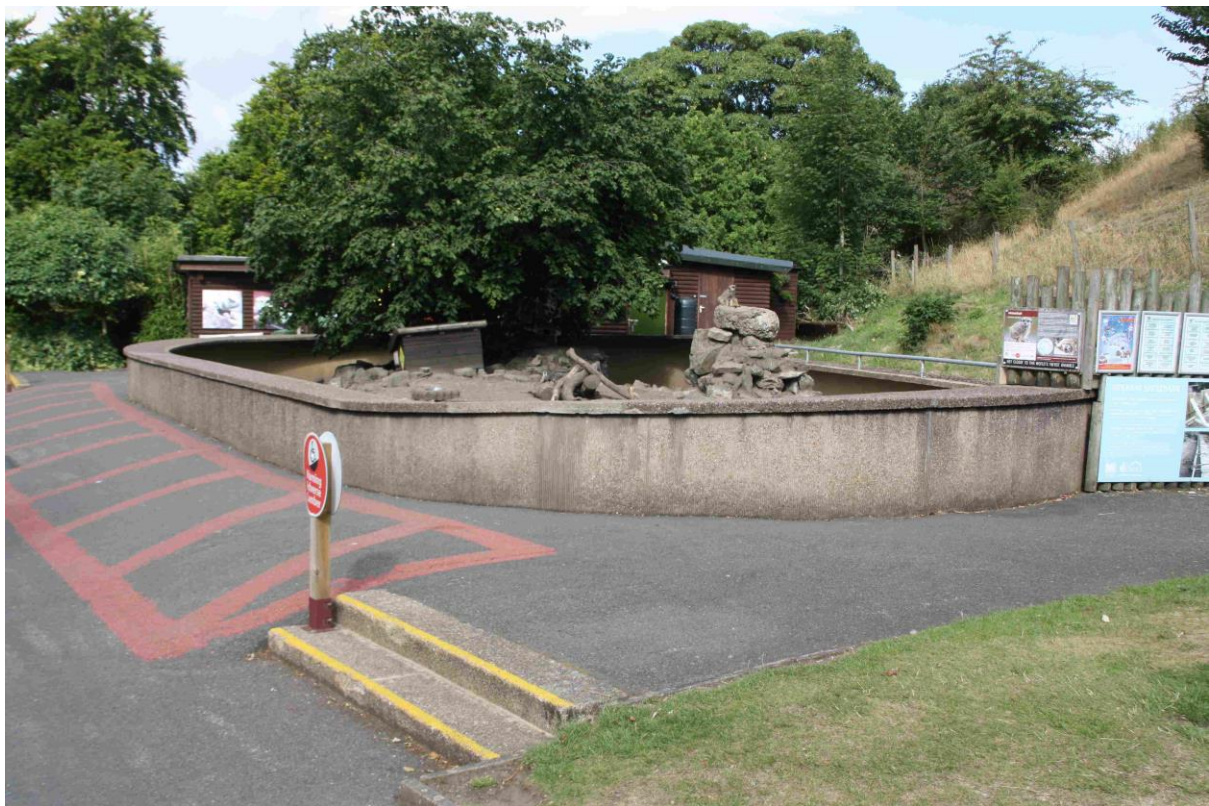
*Visual Assessments* – A visual assessment of the Meerkat enclosure showed no sign of any significant deterioration to any of the repairs, Figure 10. There were three very small areas of shrinkage cracking (<0.2mm wide) where repairs had been made to the fluted finishes to the low-level walls (due to too faster drying out of the repairs) but these were insignificant. The Meerkat enclosure was completed after the Bear Ravine in 2015, and it could be that the Dudley Zoo repair team improved their repair methods and application processes for this Tecton. Views of some of these repairs are shown in Figures 11 and 12 and they show that the repairs have now fully blending in with the parent concretes following seven years of weathering. The only other item to note is that there was a large area of the top counter which had been replaced and the top surface had been pre-weathered (brushed to remove some of the cementitious components and expose the rounded aggregate). When this had been carried out in 2015 the pre-weathered surface exactly matched the adjacent parent concrete which had been naturally weathered over 85 years. However, when it was examined in 2022 many of the small stone pebbles on the surface were now loose. This should be noted when pre-weathering to repairs is next carried out to future Tecton buildings.

Figure 10 View of the repaired Meerkat Enclosure taken 7 years after completion.

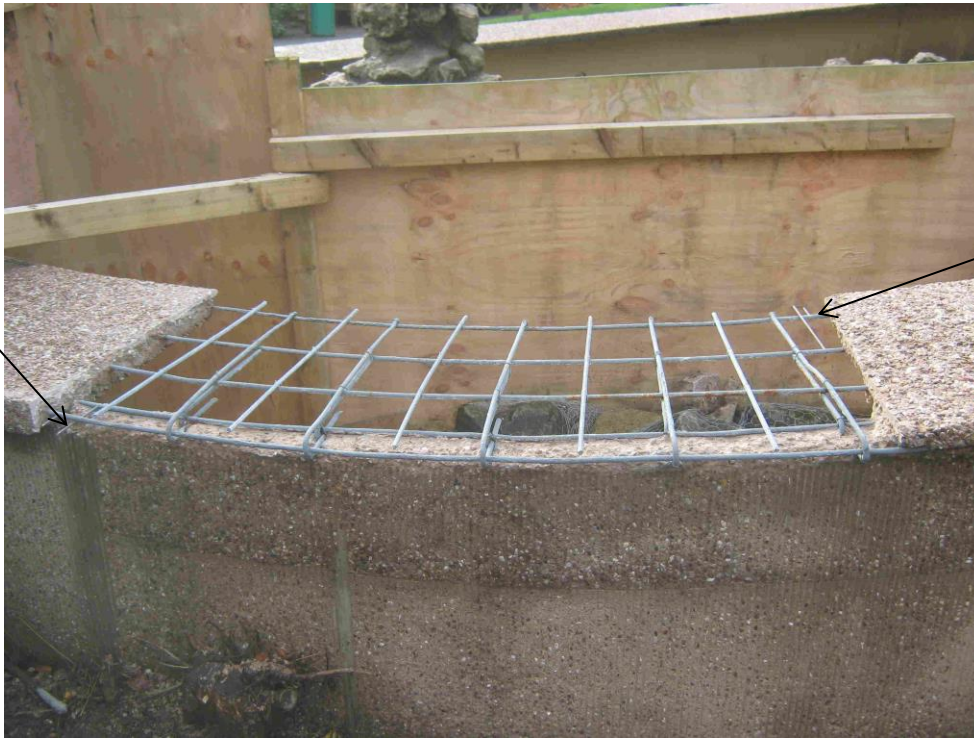
The repairs were fully completed on this structure in early 2016. 4mm stainless steel threaded bars were mechanically attached to four of the existing steel reinforcements so that measurements could be taken both in the repaired areas and also on original concrete, Figure 13. An image taken of this area of the enclosure in 2022 is shown in Figure 14.

Figure 13 Broken out section at the back of the Meerkat Enclosure (2015 - prior to repairs) showing the four stainless steel test points (right front and left back) attached to the different rebars.

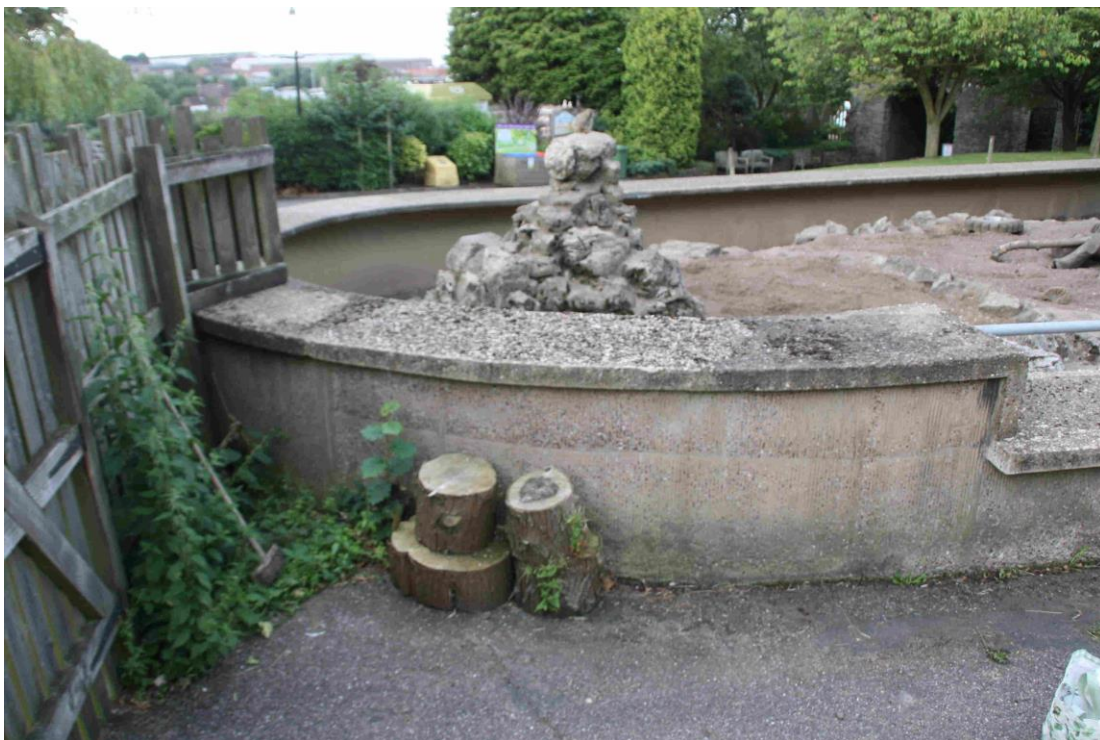
Figure 14 View of the repaired top of the wall showing it fully blending in after 7 years exposure.
