## **TECTON BUILDINGS (DUDLEY ZOO)**

(Long Term Monitoring of Like-for-Like Repairs – Assessment in 2020)

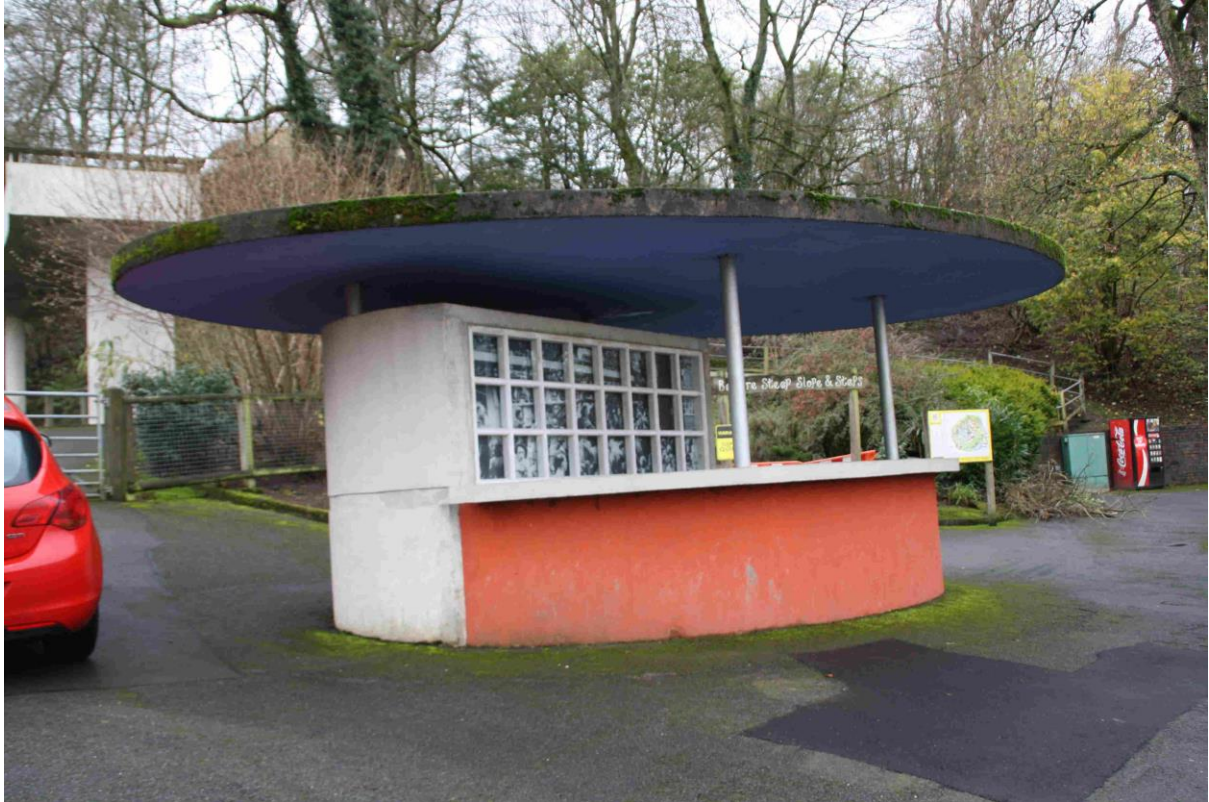
*Visual Assessment* – The kiosk was visually assessed. The repairs were still in a very good condition and no significant cracking or delamination was noted in the repaired areas, Figure 1. There was a fine crack on the top counter to the kiosk leading out from a steel column, Figure 2. This had not been noted previously and appeared to be some form of shrinkage crack emanating out from the embedded steel post.

Figure 1 View of the repaired Kiosk after 7 years exposure.

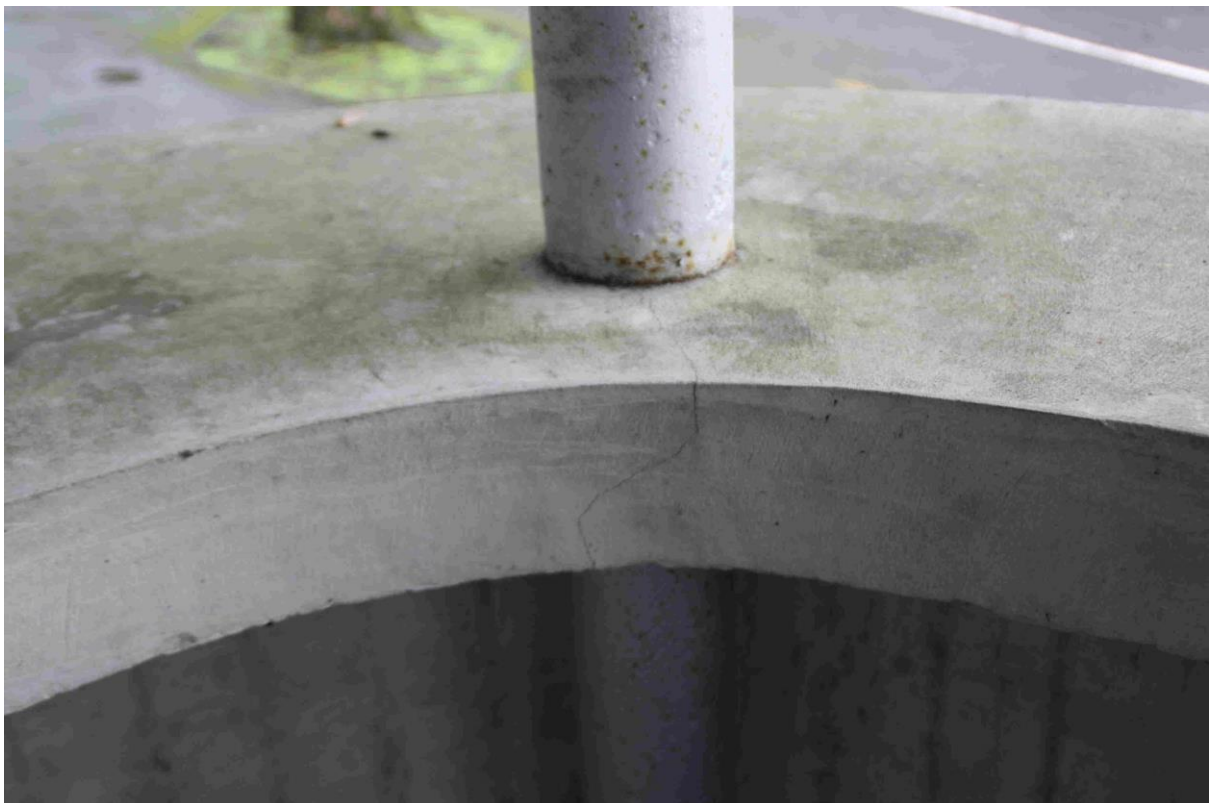
Figure 2 Fine crack leading out from the steel column, most probably due to shrinkage of the repair concrete.

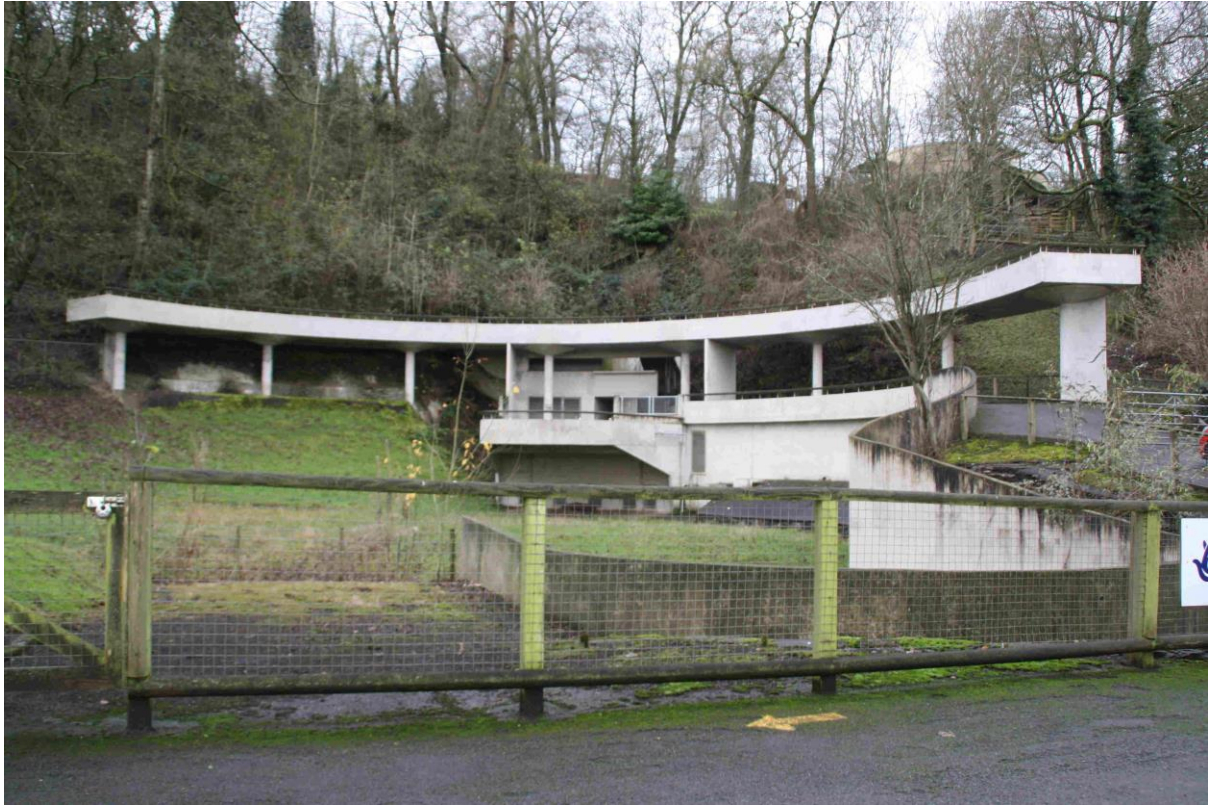
The Bear Ravine was visually assessed and from a distance this also looked to be in a good condition after six years exposure after the repairs, Figure 3. However, there were a few problems noted previously when the repairs were examined in detail. Shrinkage and sometimes moss growth (in the cracks) was noted in a few areas of the top balustrade rail on the 1<sup>st</sup> floor (shown in previous reports). Cracks were also identified in some of the corners of the balustrade plates, most possibly due to thermal movement between the repairs and the parent concretes. Shrinkage cracks were also noted to the areas of repairs on the balustrade on the ground floor. Cracking to the circular columns was also noted at the Bear Ravine. All these defects were first identified in 2017 (some 3 years after the Bear Ravine had been completed) but they do not appear to have worsened.

Figure 3 View of the repaired Bear Ravine after 6 years exposure.

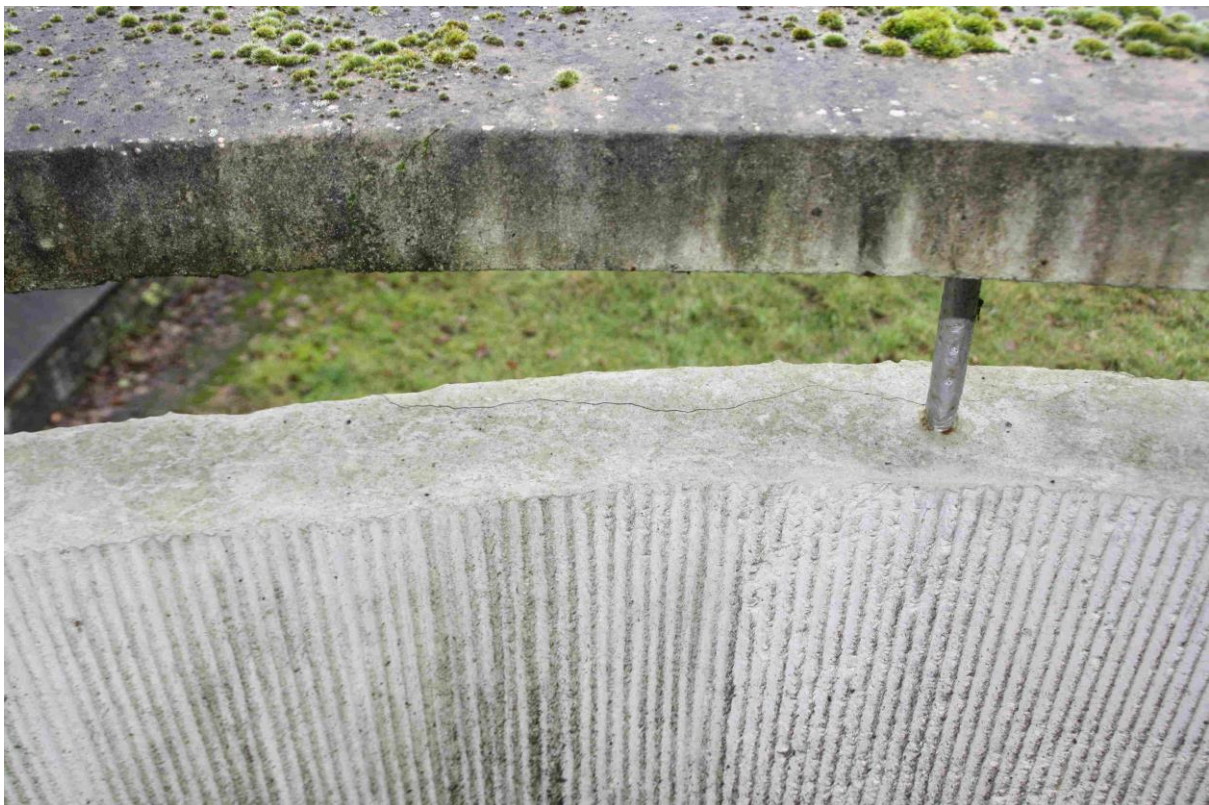
In addition, three new cracks were noted to the repaired parapet wall to the prow of the Bear Ravine, Figures 4 and 5. A shrinkage crack was also noted to a square repair patch to the fluted section of the 1<sup>st</sup> floor wall, Figure 6. This defect is almost certainly old and is most probably due to the thin section repair carried out on this particular section of the wall.

Figure 4 Cracks noted to the repaired parapet wall to the prow of the Bear Ravine. Note also the moss growth established in the fine shrinkage cracks to the upper balustrade rail.

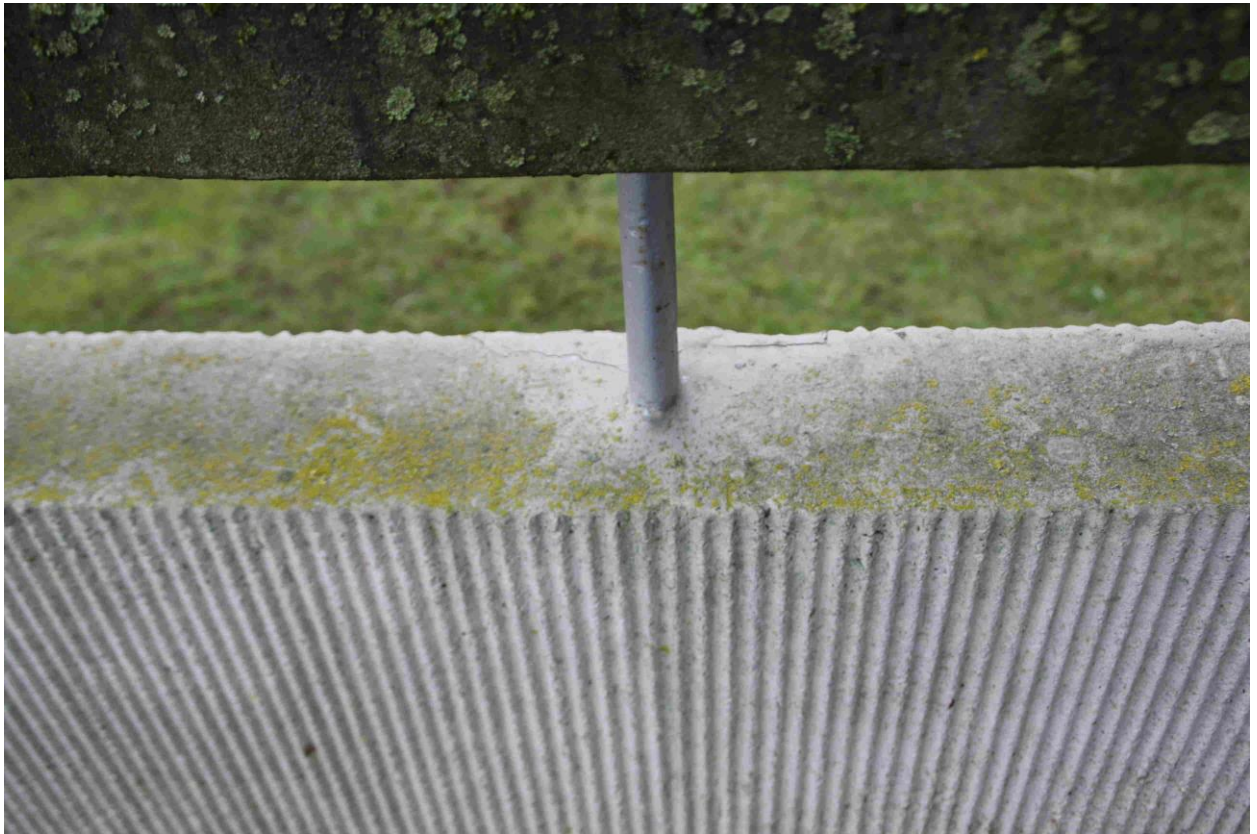
Figure 5 Another crack noted to a repaired parapet wall to the Bear Ravine.

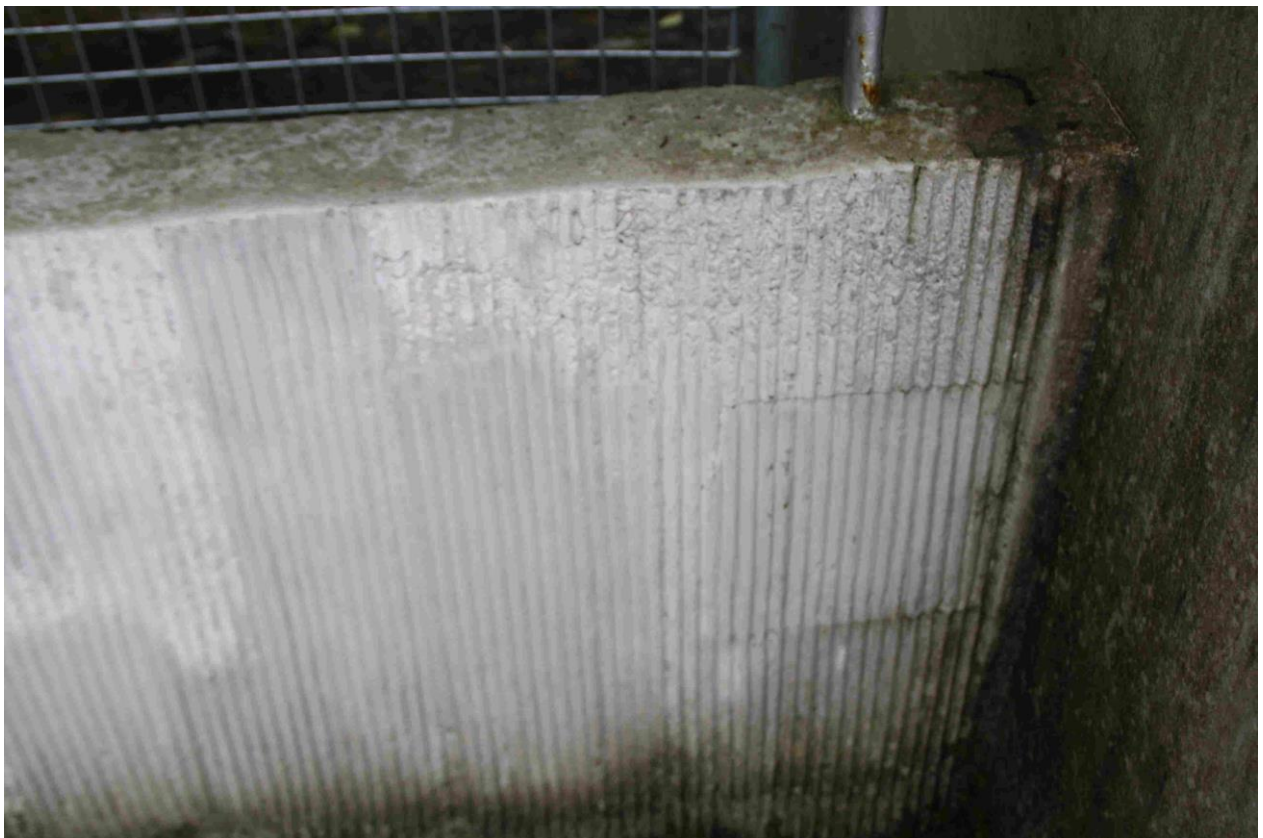
Figure 6 Classic shrinkage cracks noted around a square repair to the fluted section of the 1<sup>st</sup> floor wall.

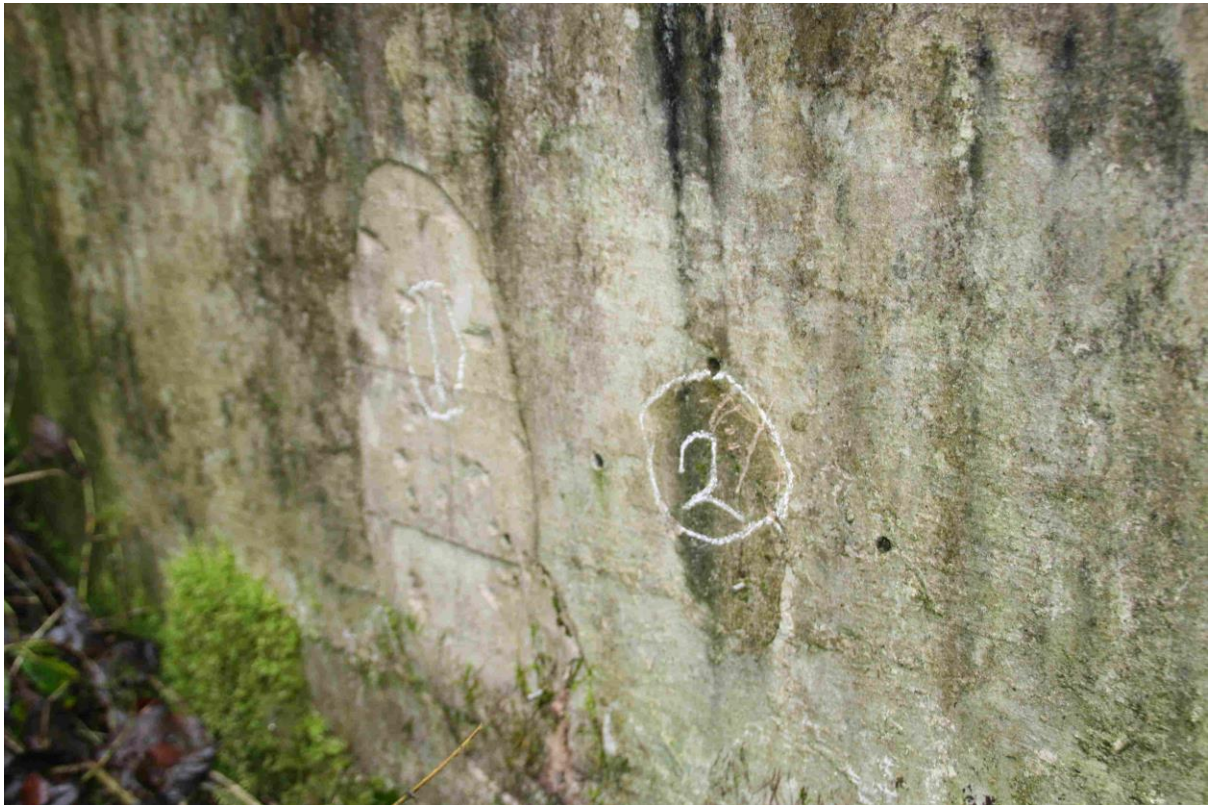
The patch repair to test areas 1 and 3 at the Bear Ravine had suffered problems soon after they had first been installed in 2014, Figures 7 and 8. Both areas had reportedly been repaired using a lightweight repair mortar (Renderoc) following instruction from HE/RTL, whereas the other two test areas (2 and 4) had been repaired using like-for-like concrete to closely match the original concrete - as were all of the other patch repairs to the Bear Ravine.

Figure 7 View of the small patch repairs (1 and 2) on the outer wall at 1<sup>st</sup> floor level. Patch 1 was made using a proprietary repair mortar and patch 2 was made using a like-for-like concrete repair.

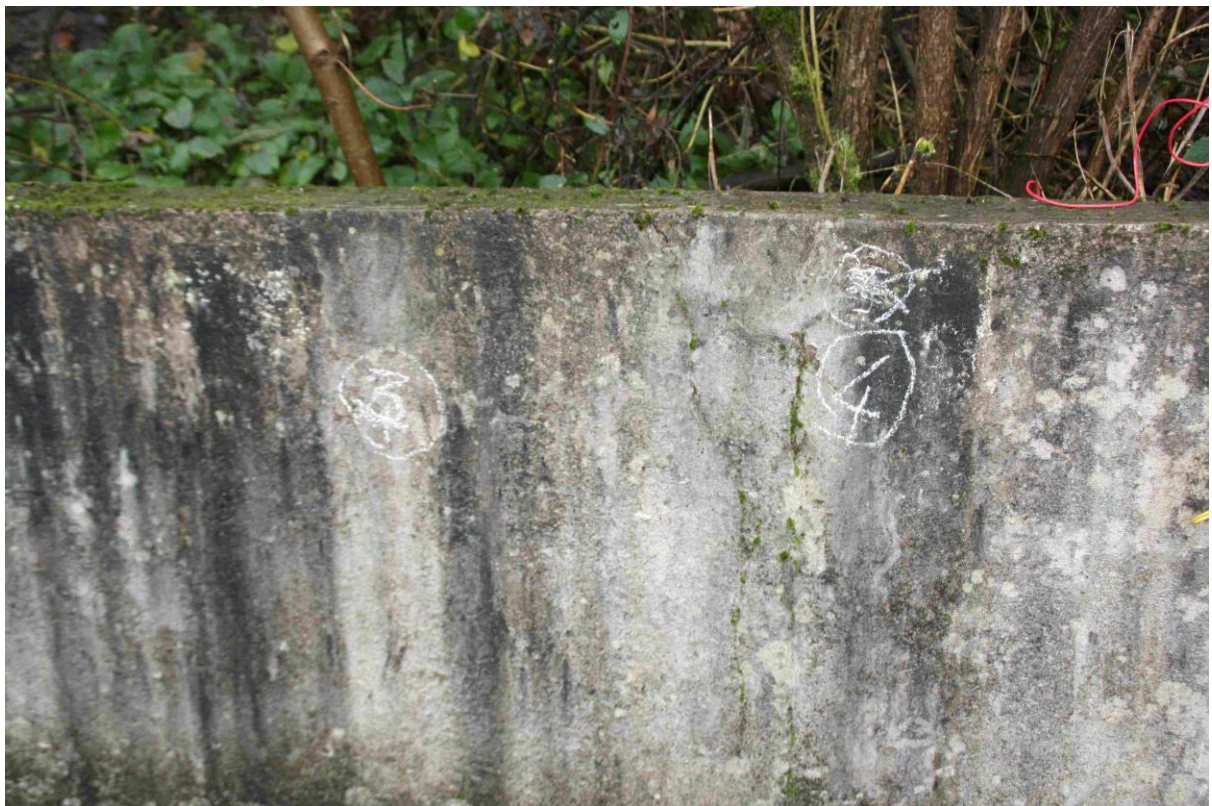
Figure 8 View of the small patch repairs (3 and 4) on the inner wall at 1<sup>st</sup> floor level. Patch 3 was made using a proprietary repair mortar and patch 4 was made using a like-for-like concrete repair. Note – shrinkage and moss growth (in cracks) for patch 4.

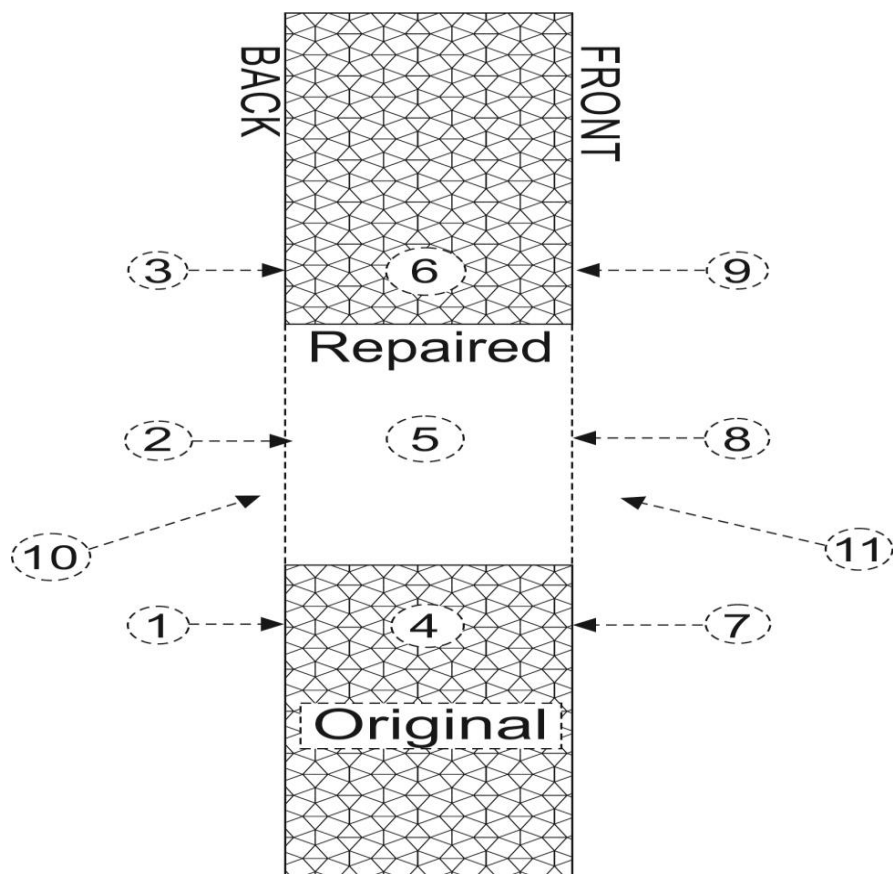
*Corrosion Rate Measurements-* Corrosion rate measurements were taken of the embedded steel reinforcements within, and around, the four test areas in both the new and original concrete on the Bear Ravine. A schematic of the test areas at test sites 3 and 4, shows where the measurements were made, Figure 9.

Figure 9 Locations where corrosion rate readings were taken in test areas 3 and 4 of the Bear Ravine 1<sup>st</sup> floor wall.

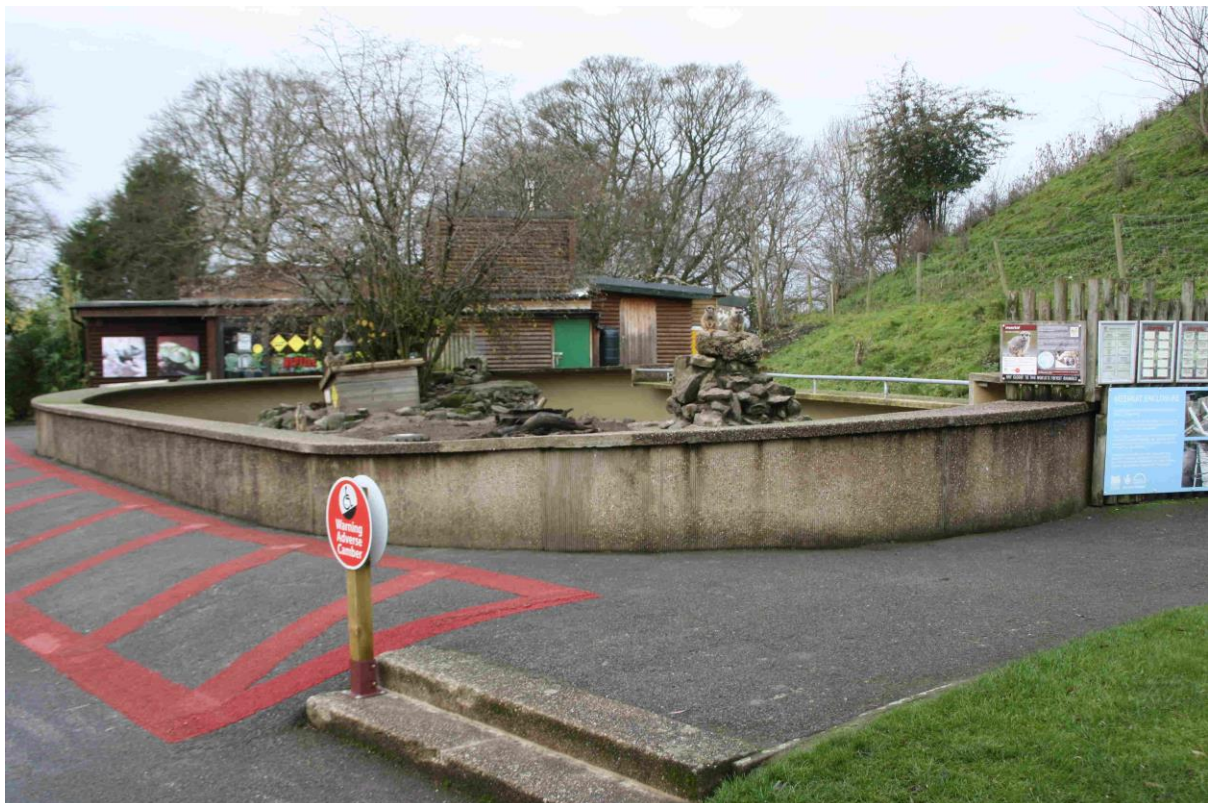
*Visual Assessments* – A visual assessment of the Meerkat enclosure showed no signs of either cracking or shrinkage of any of the repairs, Figure 10. The Meerkat enclosure was completed after the Bear Ravine, and it may be that the Dudley Zoo repair team simply improved their application process as they progressed with the repairs to the Tectons. Views of some of

Figure 10 View of the repaired Meerkat Enclosure taken 5 years after completion.

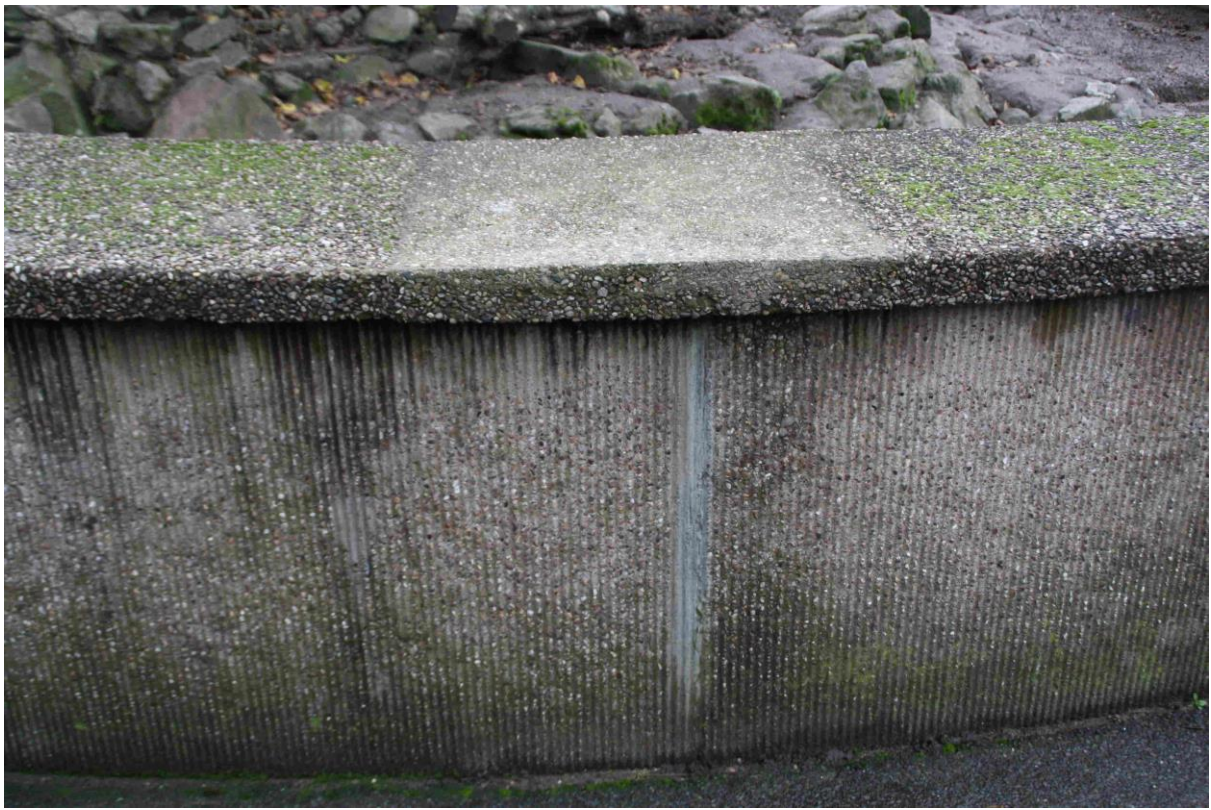
these repairs are shown in Figures 11 and 12 and they show that the repairs are now blending in with the parent concretes following five years of weathering.

Figure 11 The repairs to both the top section and vertical fluted section are now blending in with the parent concrete.

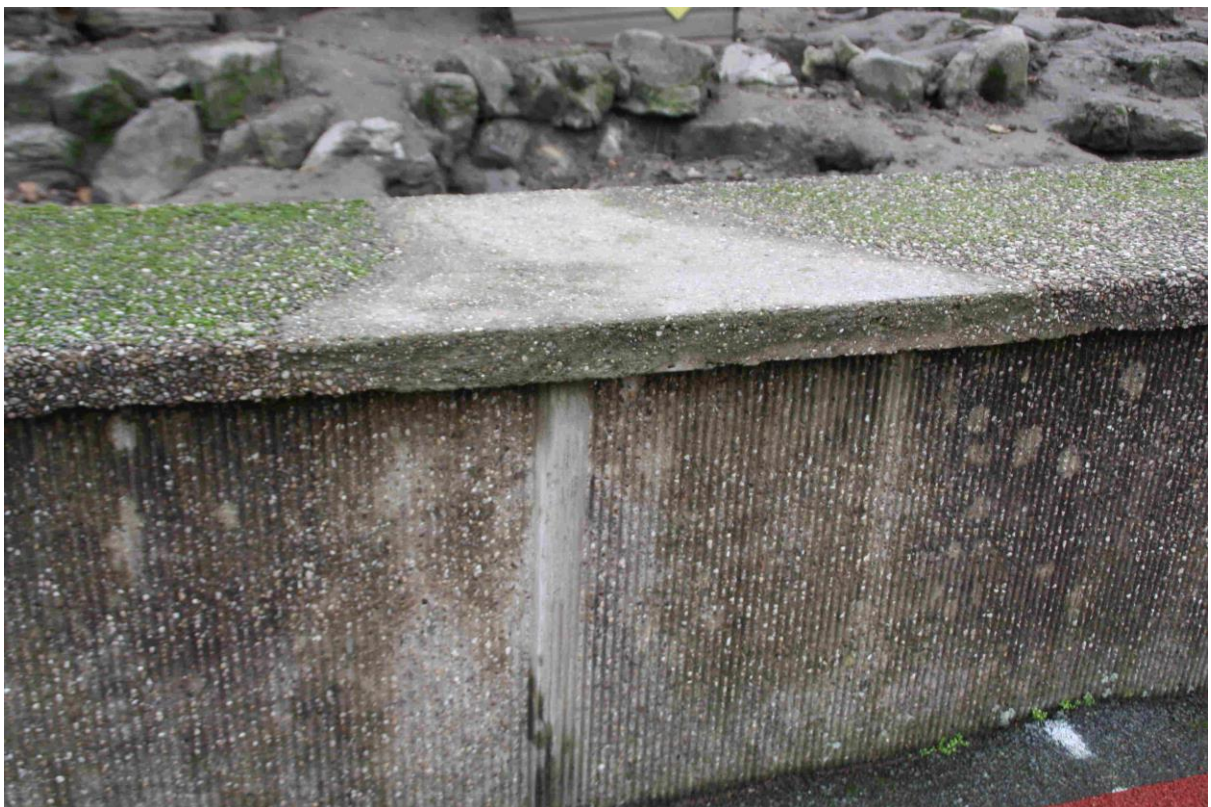
Figure 12 Another view of a repaired section (horizontal and vertical) which is also starting to blend in with the parent concrete.

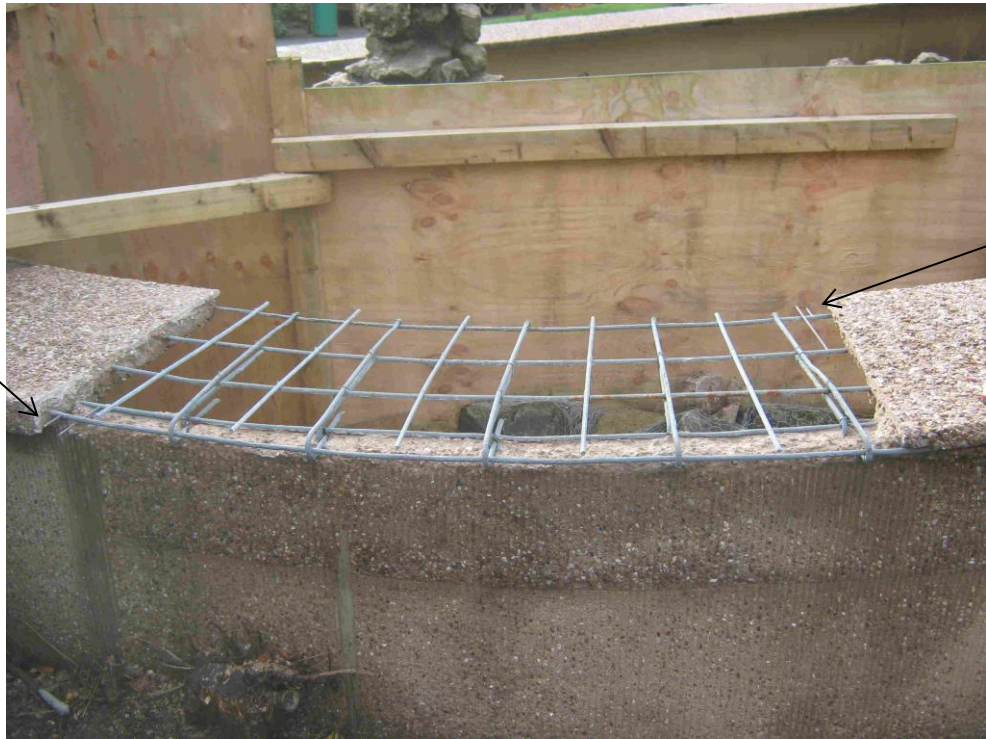
The repairs were fully completed on this structure in early 2016. 4mm stainless steel threaded bars were mechanically attached to four of the existing steel reinforcements so that measurements could be taken both in the repaired areas and also on original concrete, Figure 13. An image taken of this area of the enclosure in 2020 is shown in Figure 14. Again, this shows that these patch repairs are almost fully blended in with the parent concretes.

Figure 13 Broken out section at the back of the Meerkat Enclosure (2015 - prior to repairs) showing the four stainless steel test points (right front and left back) attached to the different rebars.

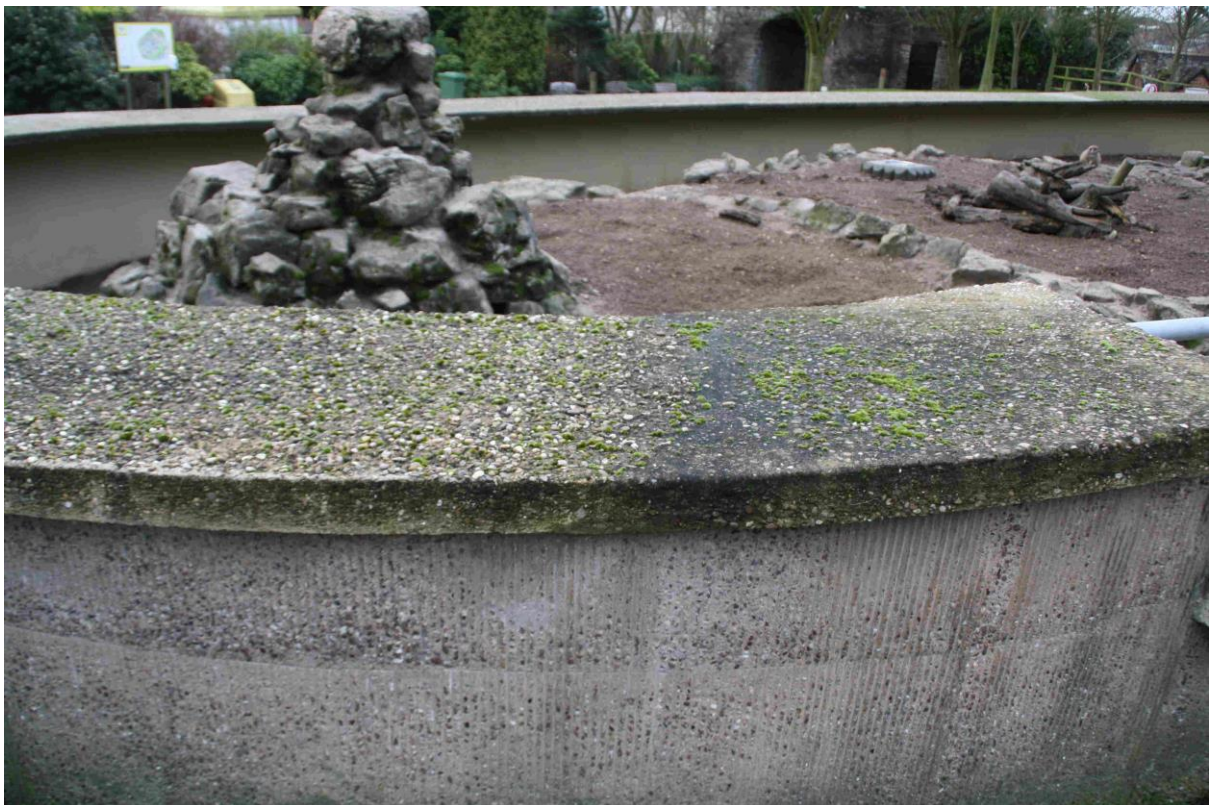
Figure 14 View of the repaired top of the wall showing it almost fully blending in after 5 years exposure.
