## TECTON BUILDINGS, DUDLEY ZOO

### Traditional Repair Schemes for Reinforced Concrete Structures

RTL Report No: 1119-01

October 2011

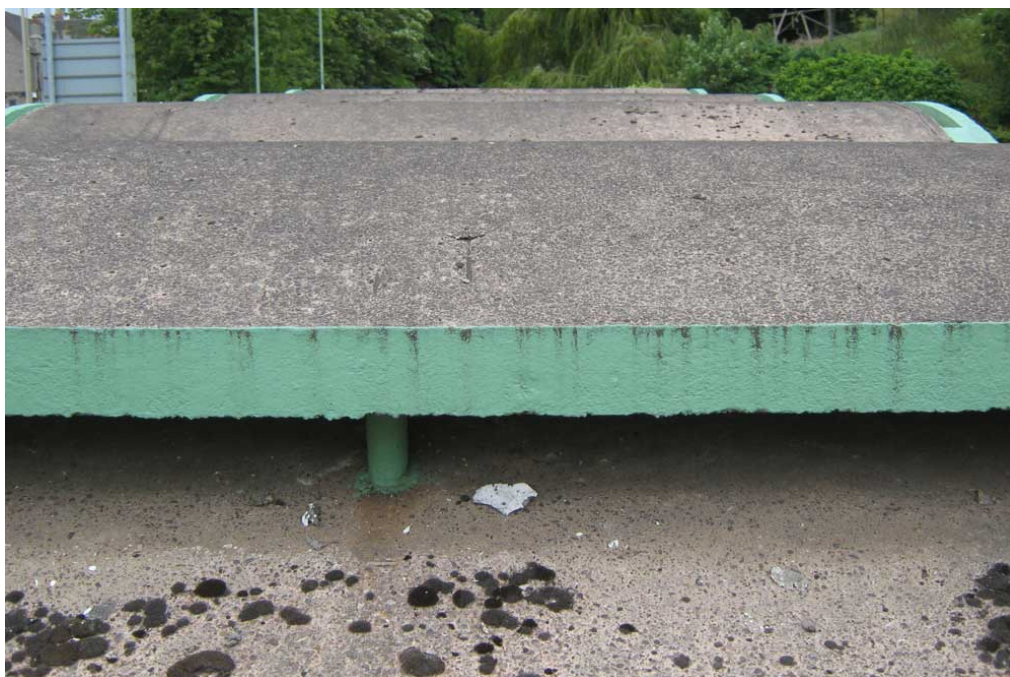
The Halcrow report had suggested that the five curved roofs had been pre-stressed but on closer inspection there appeared to be no evidence for this. The topsides of the uncoated roofs were well weathered and on first sight appeared to be in a reasonable condition. A few steel reinforcements were visible due to low cover. Some longitudinal cracks were evident on the topside of the roofs. This suggests that the underlying reinforcements are subject to corrosion and volume increase.

Figure 1: The weathering of the uncoated curved roofs of the entrance structure as compared with the unweathered surface of the underlying adjacent roof curve.

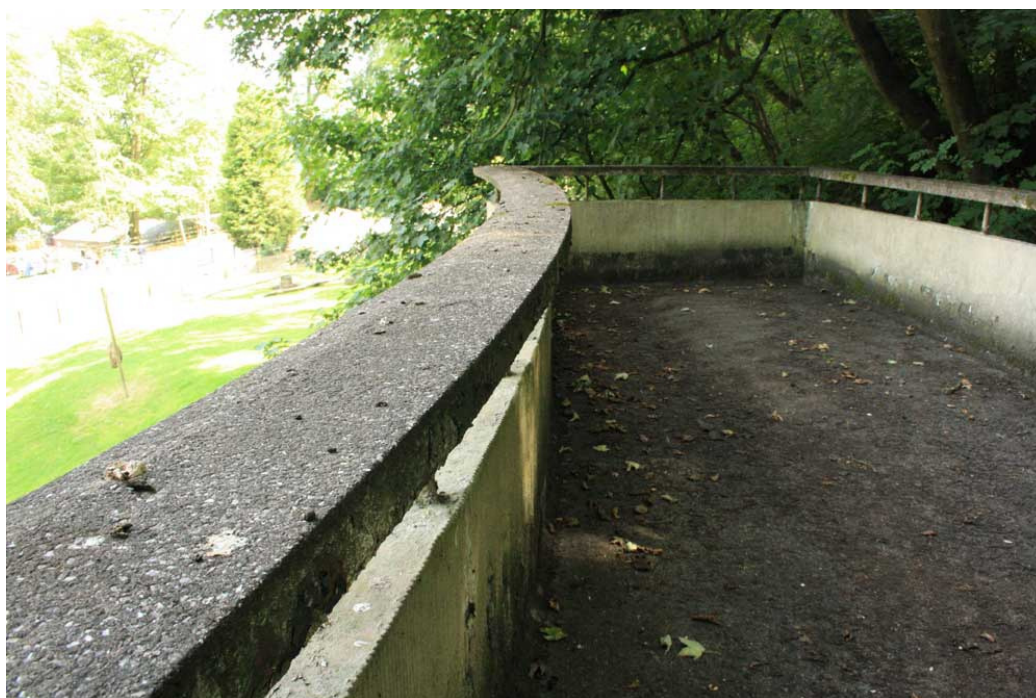
The main areas of concrete that were found to be uncoated on the four Tectons are the roof structures of both the Kiosk and the Entrance Structure and the balustrade rails on the Bear Ravine. Damage has resulted from failure to coat the roofs and this is considered to be a design fault. It is therefore proposed that the top surfaces of the concrete roofs be cleaned down to remove plant growth, repaired if necessary, and some form of bituminous coating applied to give long term protection to the concrete. The coatings should overlap the edges of the roof slabs and a drip should also be provided. The only area that might require some form of surface preparation is the balustrade rails which are naturally weathered with the aggregates exposed. Repair or replacement of the balustrade rails should

Figure 2: Weathering of the cementitious components of the concrete has left the aggregates exposed on the Bear Ravine's balustrade rail.

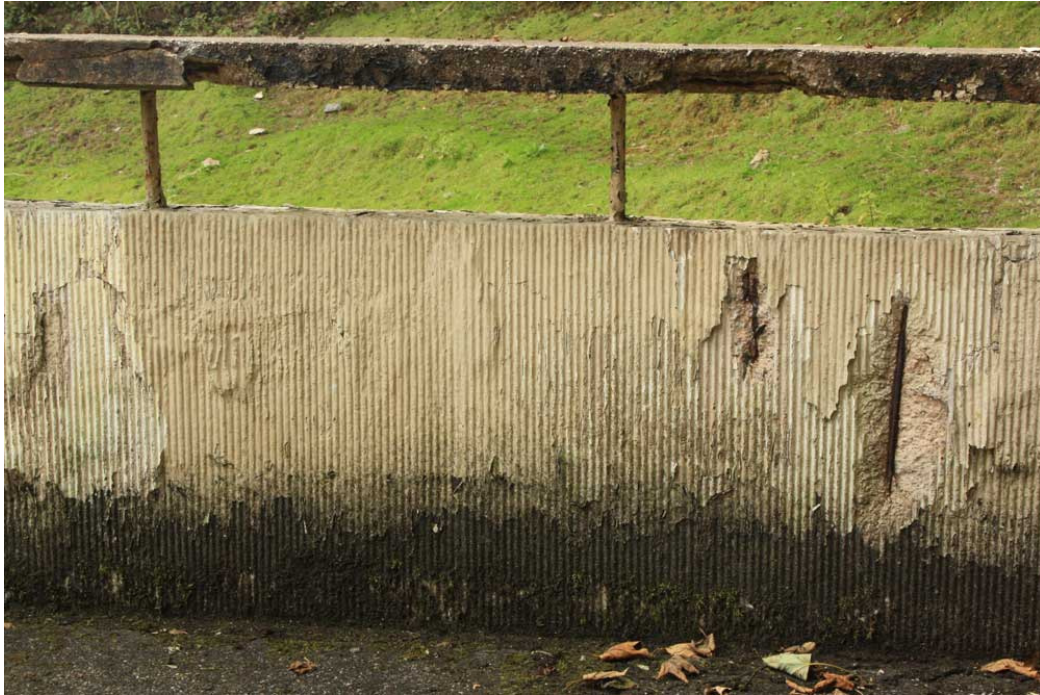
Figure 3: The corrugated finish was achieved using a thin cementitious layer applied on the base concrete.

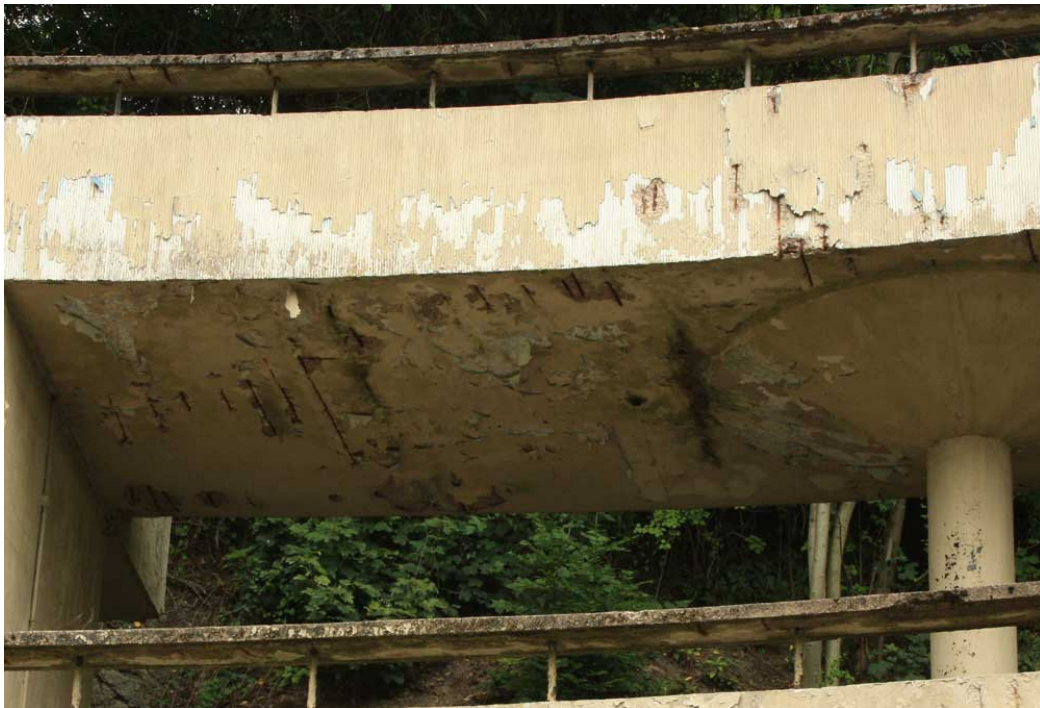
Figure 4: The soffit of the upper platform showed significant corrosion of the low-lying reinforcements.

The upper platform is not as badly damaged as the lower platform and patch repair of both the parapet walls and balustrade rails may be sufficient to achieve an extended life. The soffit of the upper platform will require repair using the same method as that for the underside of the cantilevered balcony. There are many other areas of the Bear Ravine that will require repair or replacement of the concrete and also repair to metal columns and balustrade posts and reference should be made to the

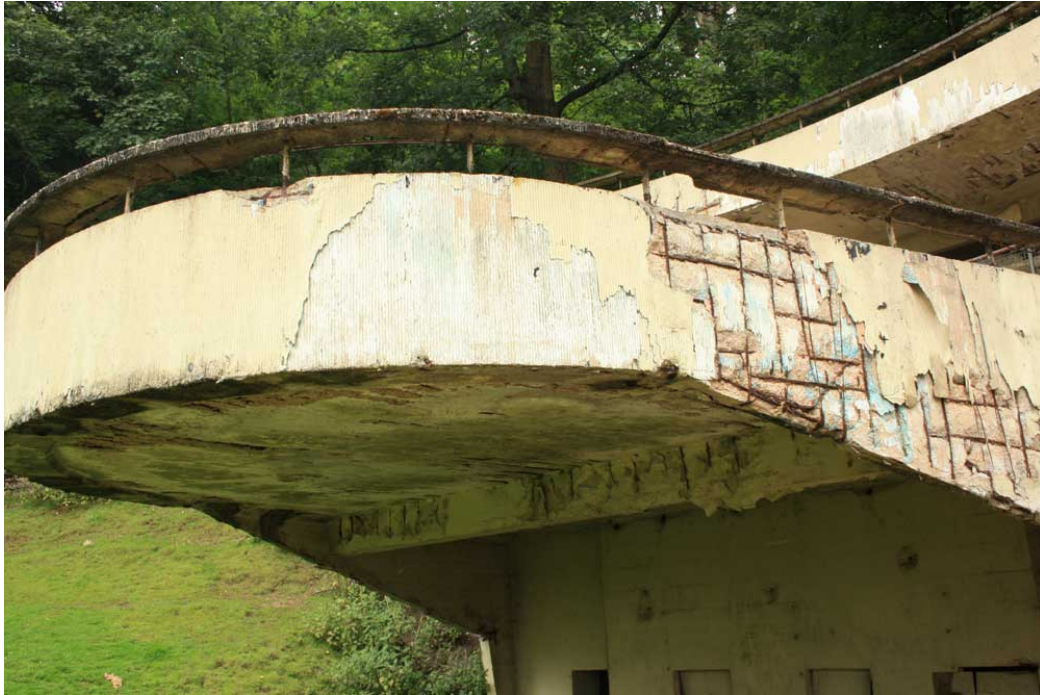
The parapet walls of the cantilevered balcony were particularly badly affected and the carbonation would have occurred on both sides of this relatively thin wall. The parapet walls on the upper and lower platforms were also found to be in a similar condition. The circular mushroom headed columns and also the end column walls also showed many areas where the concrete cover was low. This structure is likely to require significant removal and replacement of cover.

Figure 5: The cantilevered balcony of the Bear Ravine was in a particularly poor condition.

The parapet walls and lower walls below the cantilevered balcony have been severely carbonated from both sides and the wall is relatively thin. It is therefore recommended that this be completely replaced. The floors of the balcony (and other floors) are still in a reasonable condition and patch repair should be sufficient for any exposed steel reinforcement. The soffit of the cantilevered balcony and associated support beams are in a very poor condition and this is likely to require complete replacement of the concrete cover. The balcony will require some form of support before any repair work is carried out on it. The concrete cover should be removed and any low-lying reinforcements forced back into the surface.

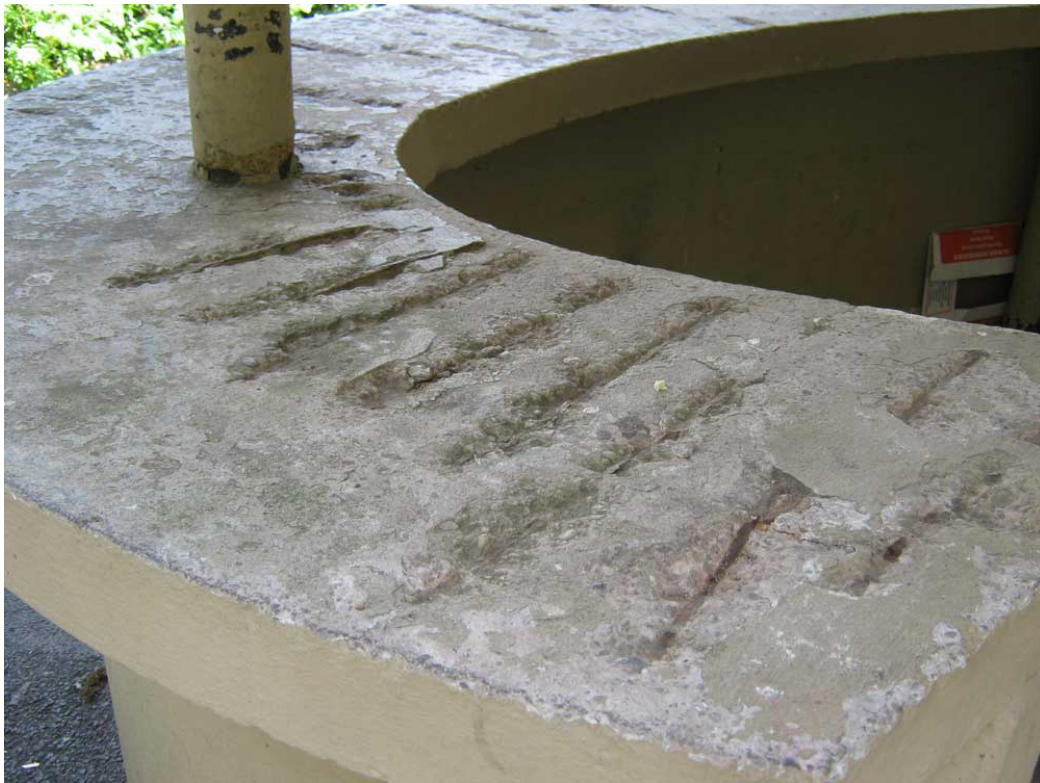
Figure 6: Corroding reinforcements are exposed due to low concrete cover on the Kiosk worktop.

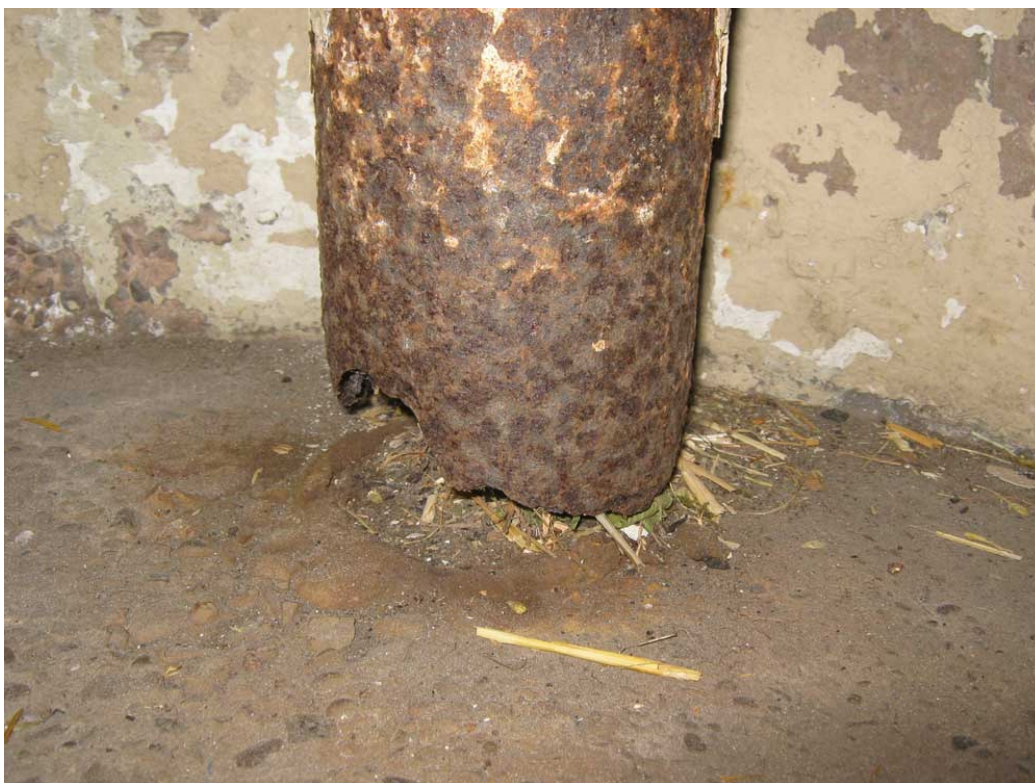
Figure 7: Corrosion damage to the base of a steel pillar within the Kiosk.

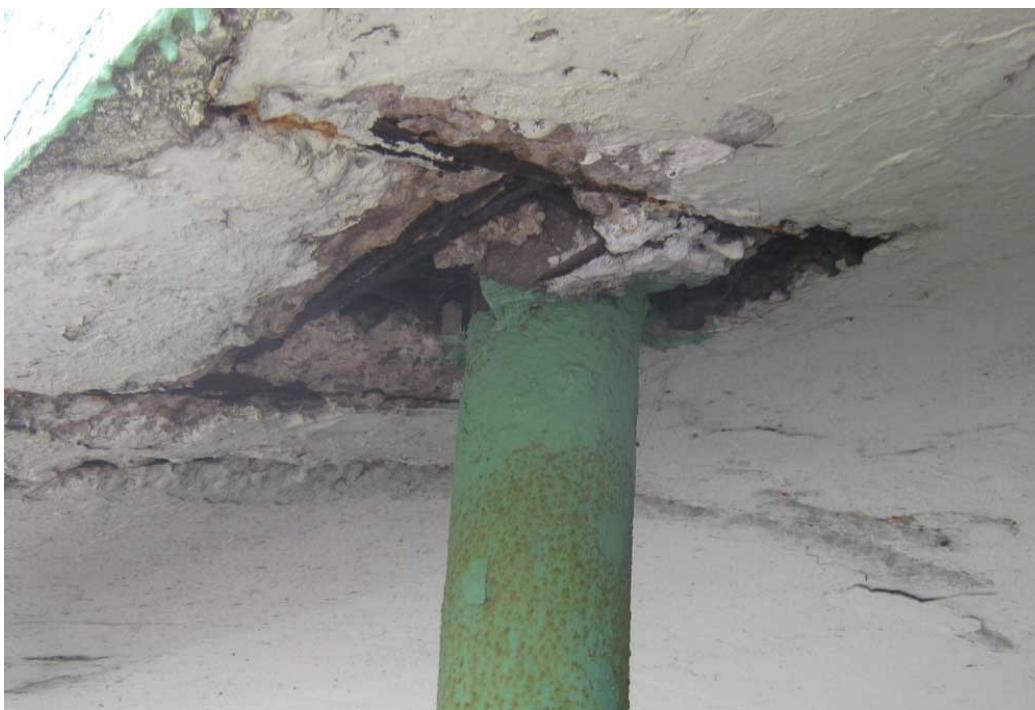
The most significant damage was associated with the steel pillars as they passed through the concrete, Figure 8. Expansion of the corroding pillars has resulted in extensive cracking and delamination of the surrounding concrete on both the underside and topside. More information is given in Appendix A and in the Halcrow Report.

Figure 8: Corrosion damage to the underside of the sinusoidal roof of the entrance.

Repairs are also required on the bottom face of the roof slabs where exposed steel reinforcements are present. The cover needs to be removed and the steel forced back into the concrete roof - if possible. Repair should be similar to that for the soffits – described earlier. Patch repair is also required for the remainder of the concrete and work is also required to the steel support columns, which have suffered from corrosion. Again, the repaired structure should be suitably coated.

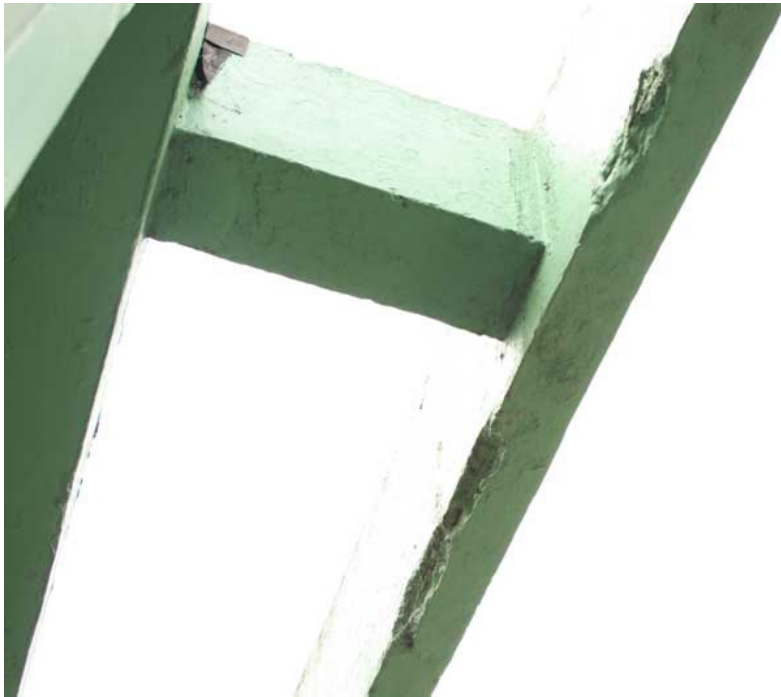
Figure 9: Localised damage to the flying edge beam of the Safari Shop.

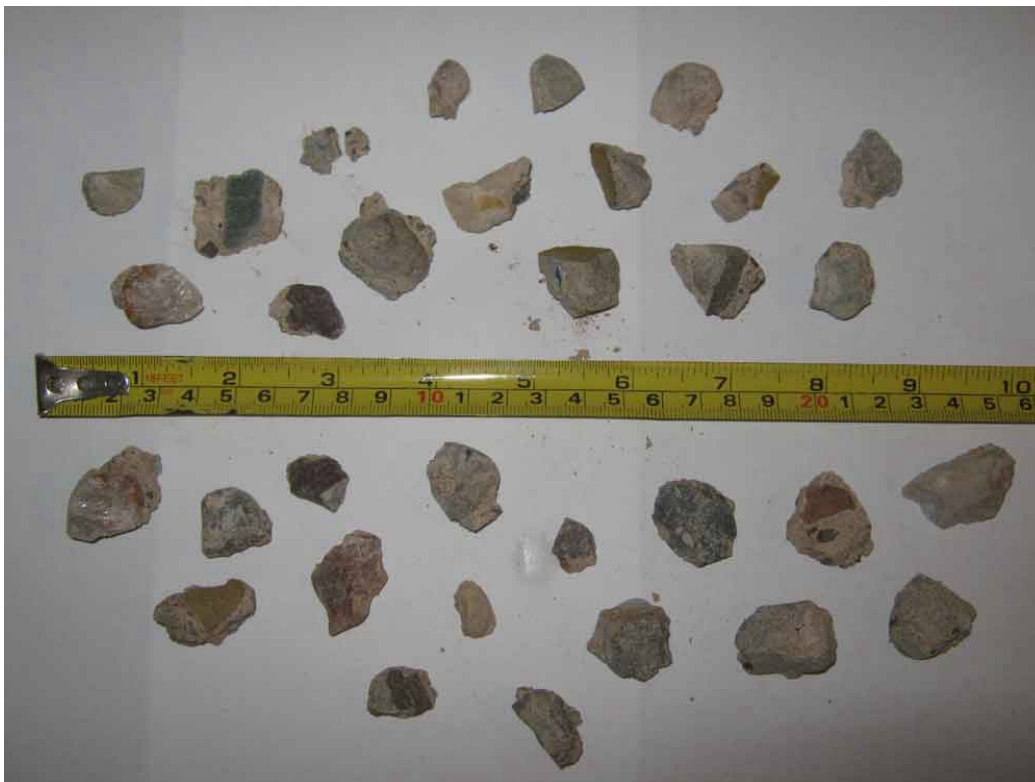
Figure 10: An example of the different types of aggregate used in the concrete mix.

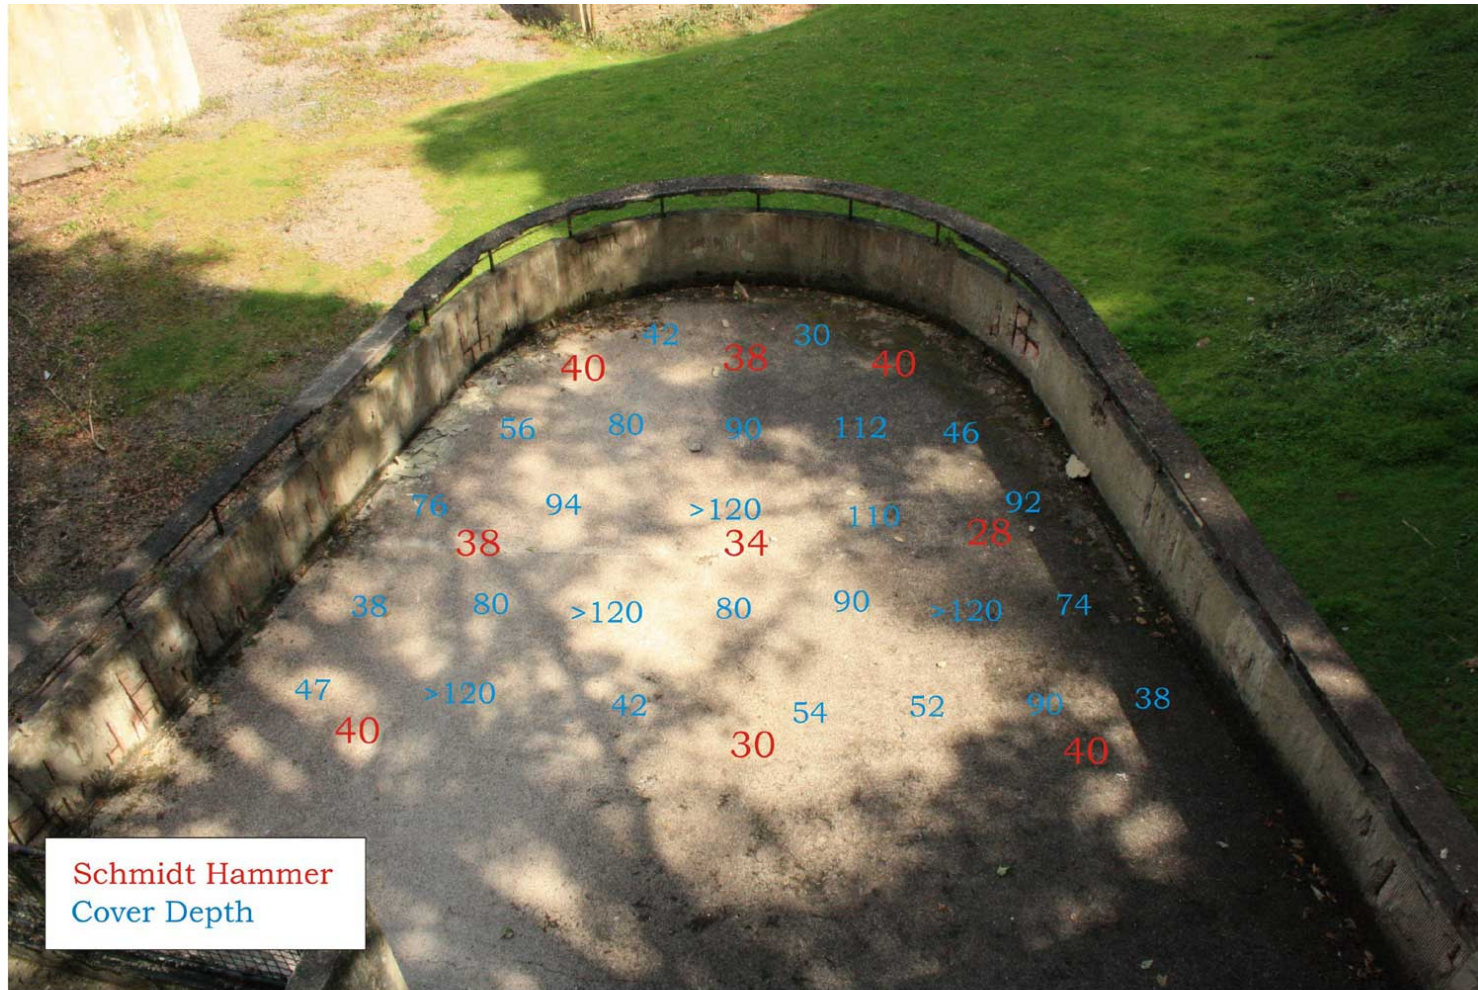
Figure A-2: Cantilevered Balcony Topside (Area A)

*Bear Ravine* – The floor of the cantilevered balcony showed cover readings of between 30 to 110mm, Figure A-2. Because only a few readings were below 40mm this concrete was still in a reasonably good condition. The balcony wall and parapet showed cover readings of between 16 to 49mm and was subsequently in a very poor condition, Figure A-3. The central staircase wall on the lower platform showed cover readings between 8 and 67mm with a large area of delamination where readings were lowest, Figure A-4. The concrete retaining wall showed cover readings of between 41 to 106mm and this showed no obvious damage, apart from the exfoliating paint coating, Figure A-5. The upper platform parapet (external surface) showed cover readings of between 26 to 52mm and the soffit between 15 to 35mm, Figure A-6. Again, most of the delamination was associated with the areas of low cover. Note the exfoliation of some form a fairing coat that had been applied to the external parapet surface. The upper platform parapet (internal surface) showed cover readings of between 17 to 36mm with significant delamination and exposed reinforcements close to where the low cover was identified, Figure A-7.

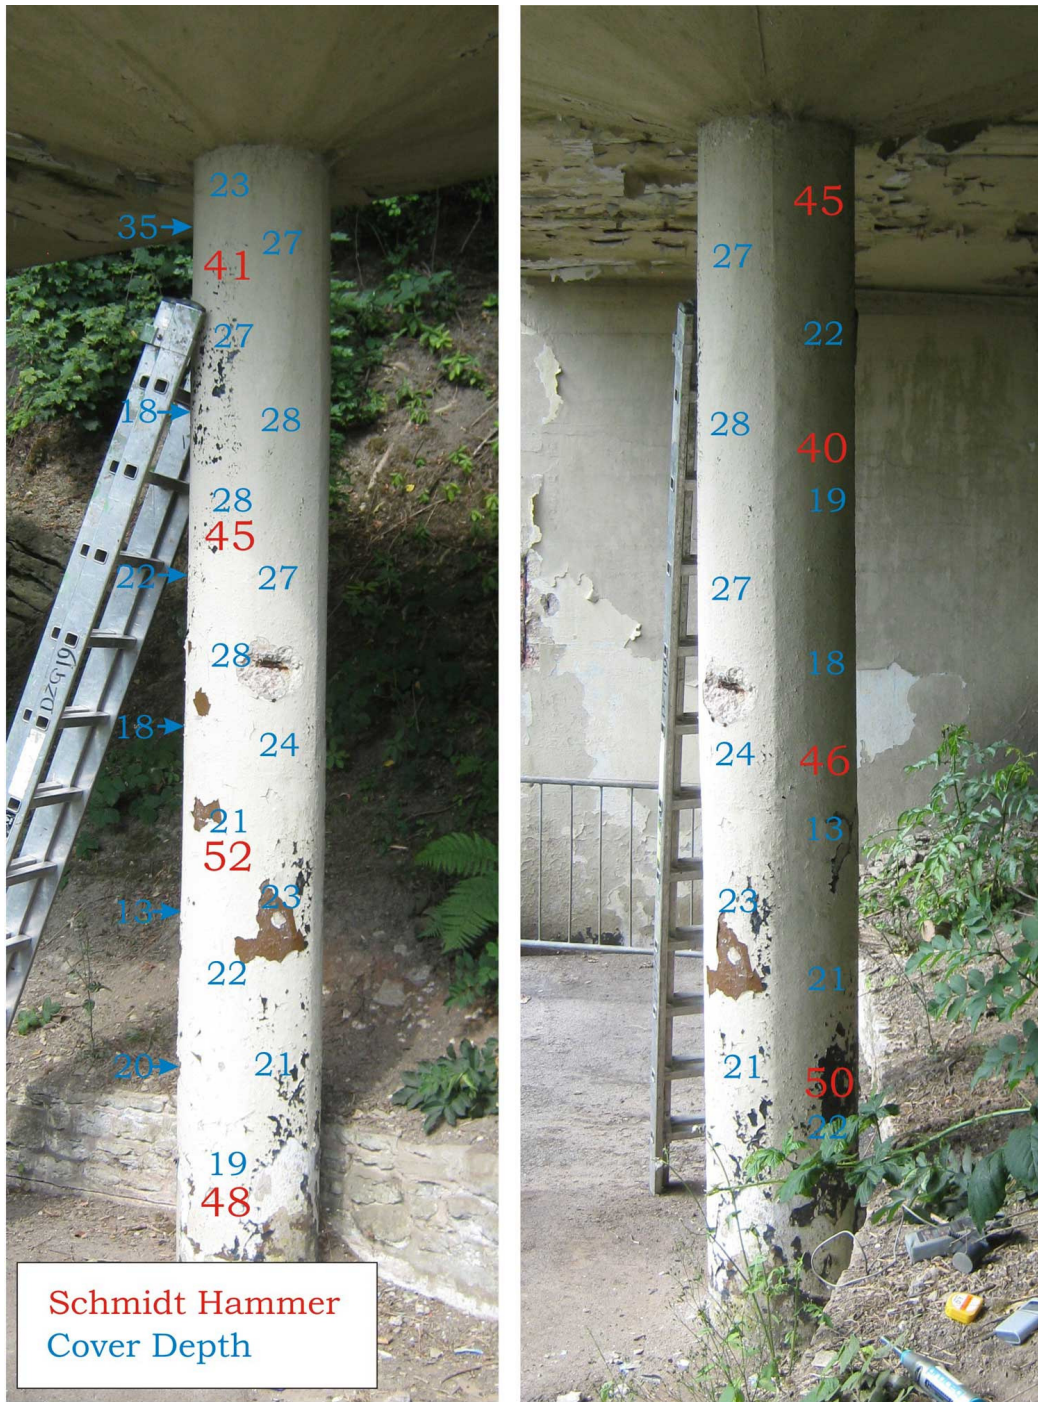
Figure A-8: Mushroom Headed Column (Area G)

The mushroom headed columns showed very low general cover of between 13 to 35mm and delamination and exposed reinforcements in selected areas, Figure A-8. One of the end column walls was assessed and this showed cover readings of between 18 to 44mm and extensive damage, Figure A-9.

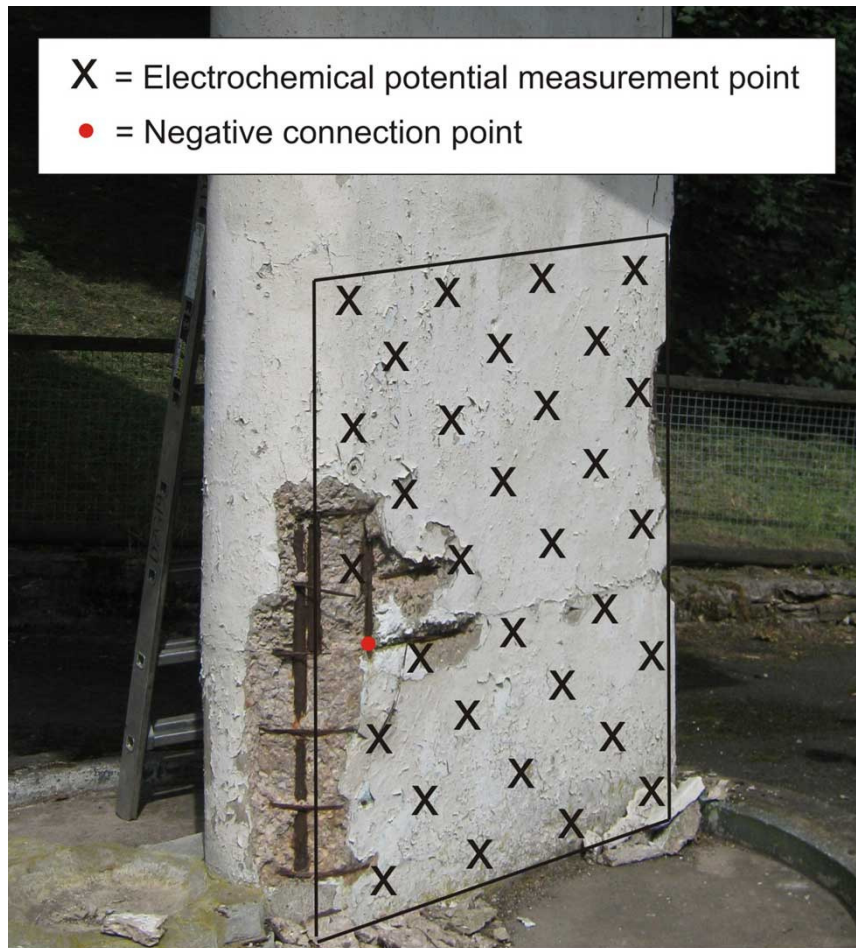
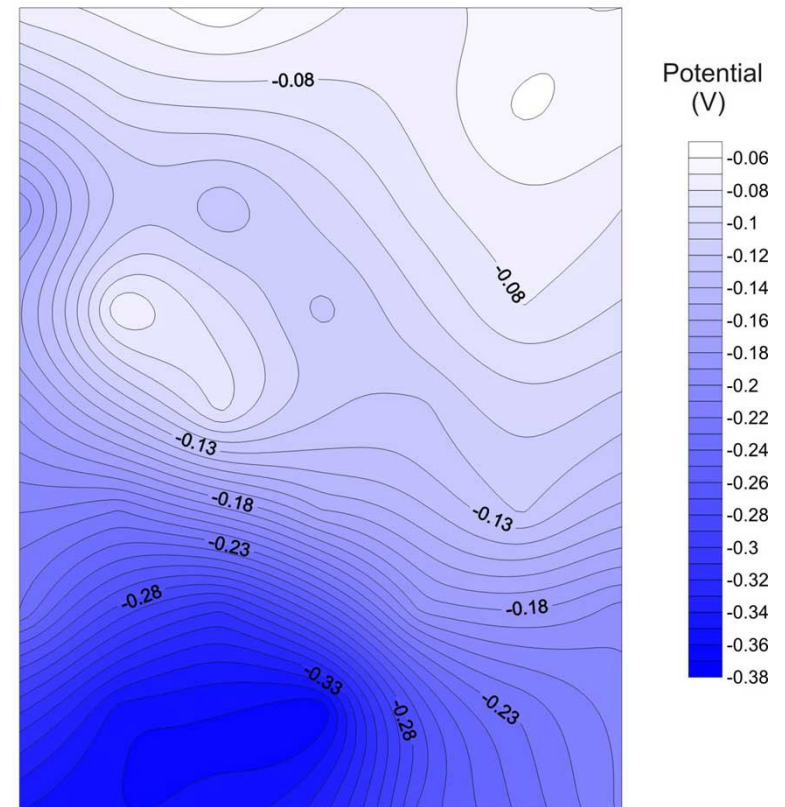
Figure A-10: Natural Potential (half-cell) map of part of Area H

Finally, natural potentials (half-cells readings) were taken on one of the end column walls of the Bear Ravine and this confirmed that corrosion of the steel reinforcements was ongoing, Figure A-10. Natural potentials between  $-250\text{mV}$  and  $-350\text{mV}$  indicate that the steel has a medium risk of ongoing corrosion. And potentials more negative than  $-350\text{mV}$  indicate a high risk of ongoing corrosion. These results indicate that the corrosion at the base of the column wall is ongoing. Further half-cell mapping was suspended as these results were not particularly helpful for the repair work.

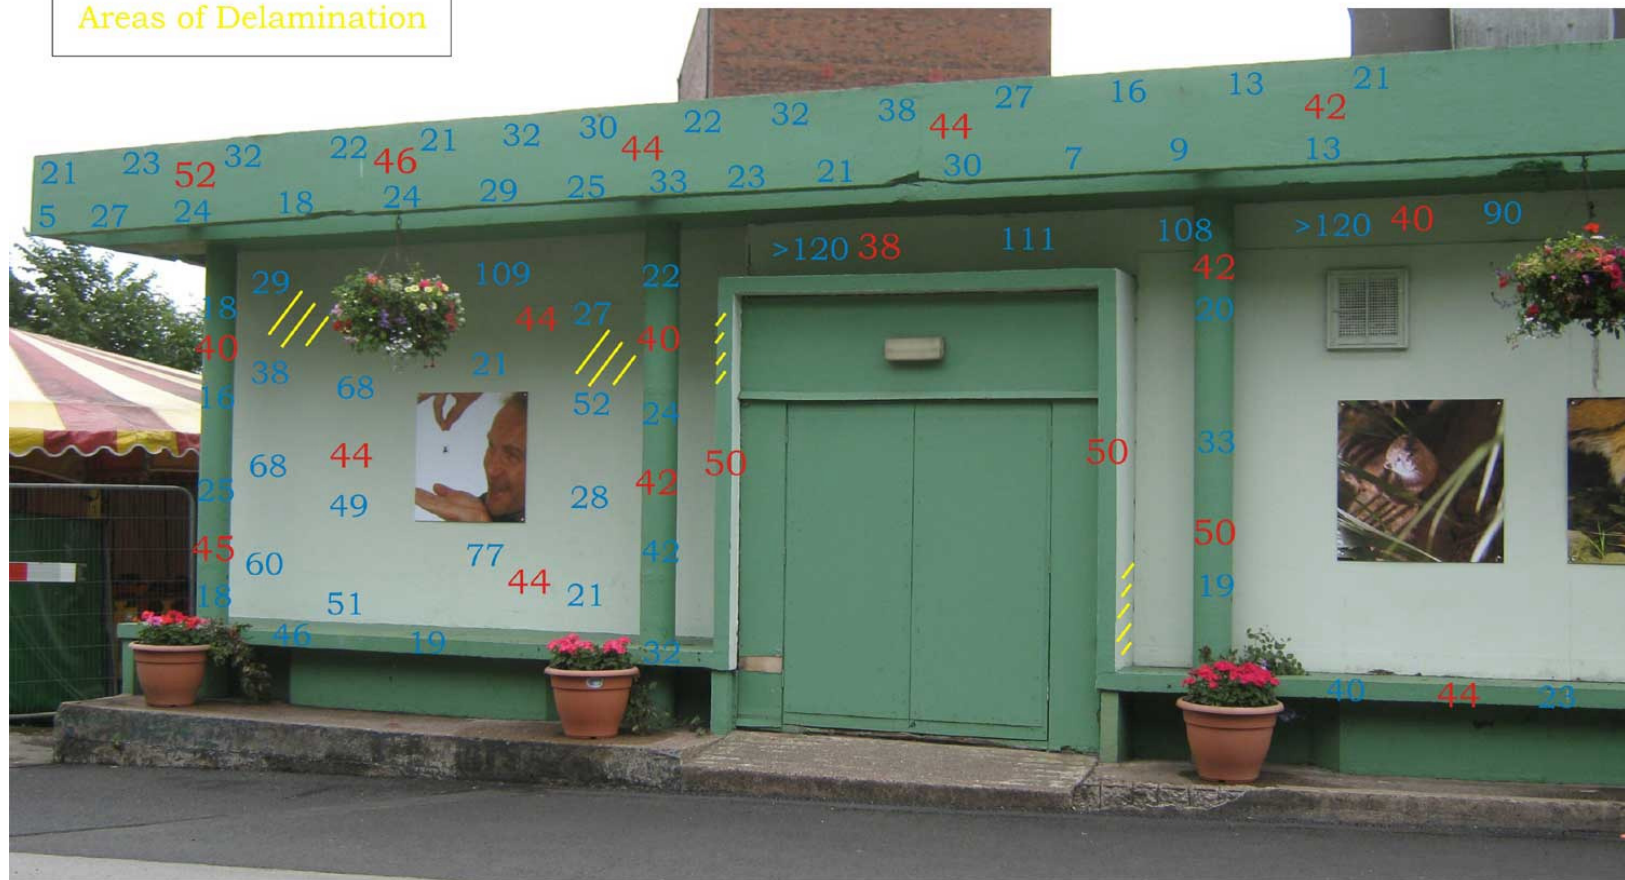
Figure A-18: Left side of the night club building (Area A)

*Station Café* – The left side of the nightclub was assessed for cover and this showed readings of between 16 to 109mm, Figure A-18. The areas of low cover were coincident with delamination and corrosion of the steel reinforcements. The right side of the nightclub showed cover readings of between 8 to 40mm and again delamination was evident in the low cover areas, Figure A-19. The shop was similar in that the concrete cover was between 9 to 46mm and damage was associated with the low cover areas.

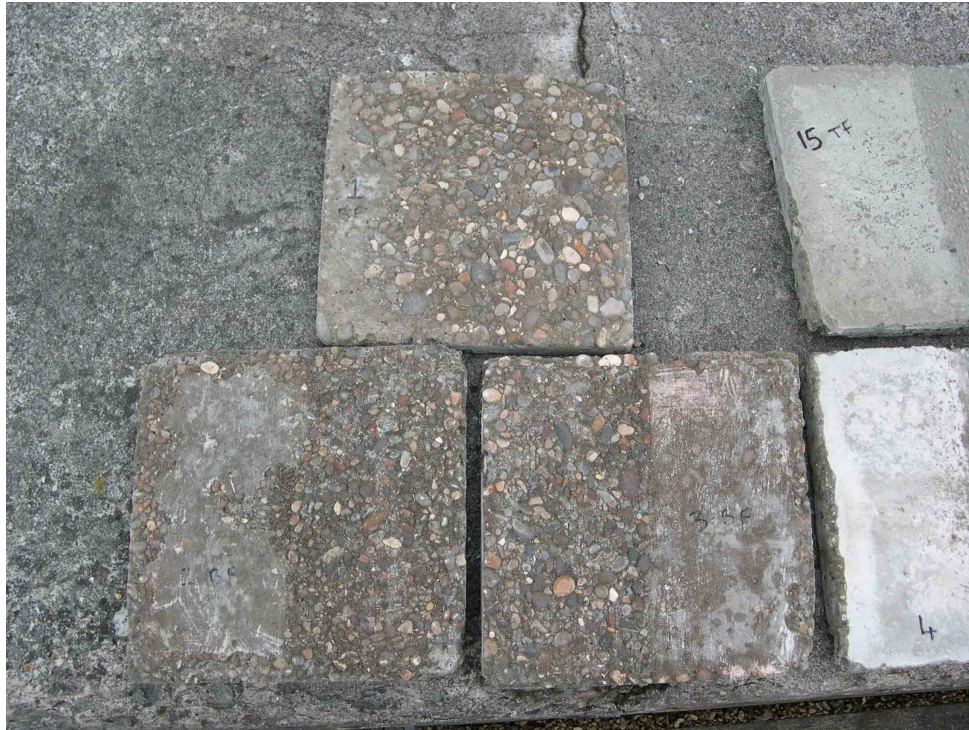
Figure C-1 Flag library using different constituents for the test concrete. Some of the flags used retardants together with post-brushing of the surfaces.
