## **Dudley Zoo**

### **Structural Engineering Report on the Four Tectons**

Project No: 300/01

Date: 9 December 2011

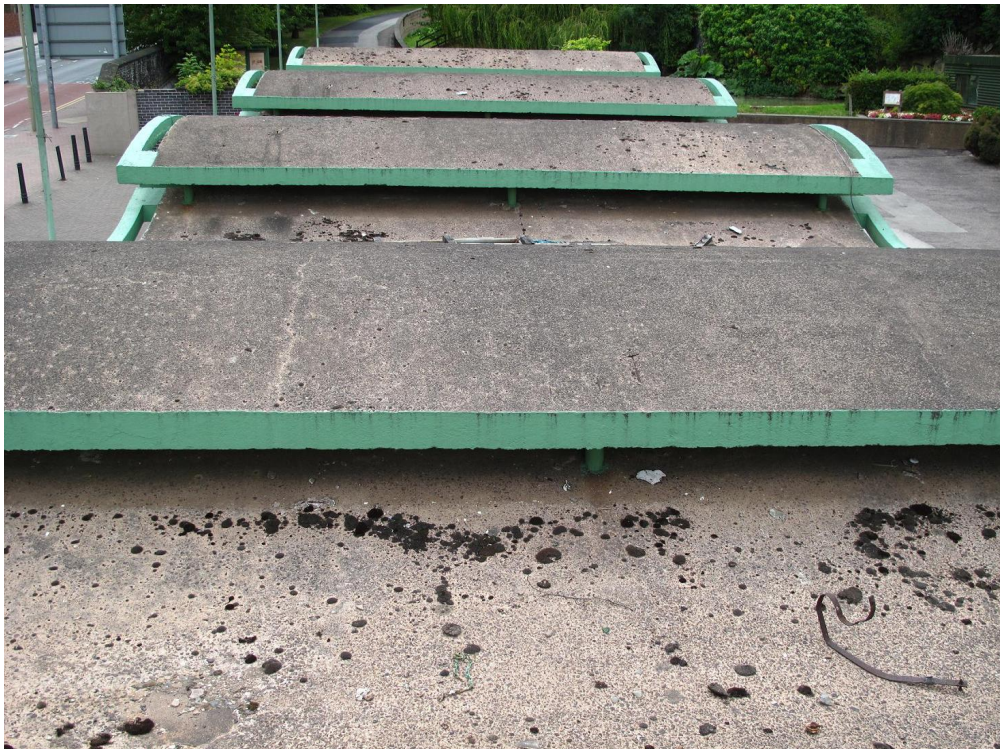
Top of roof slab

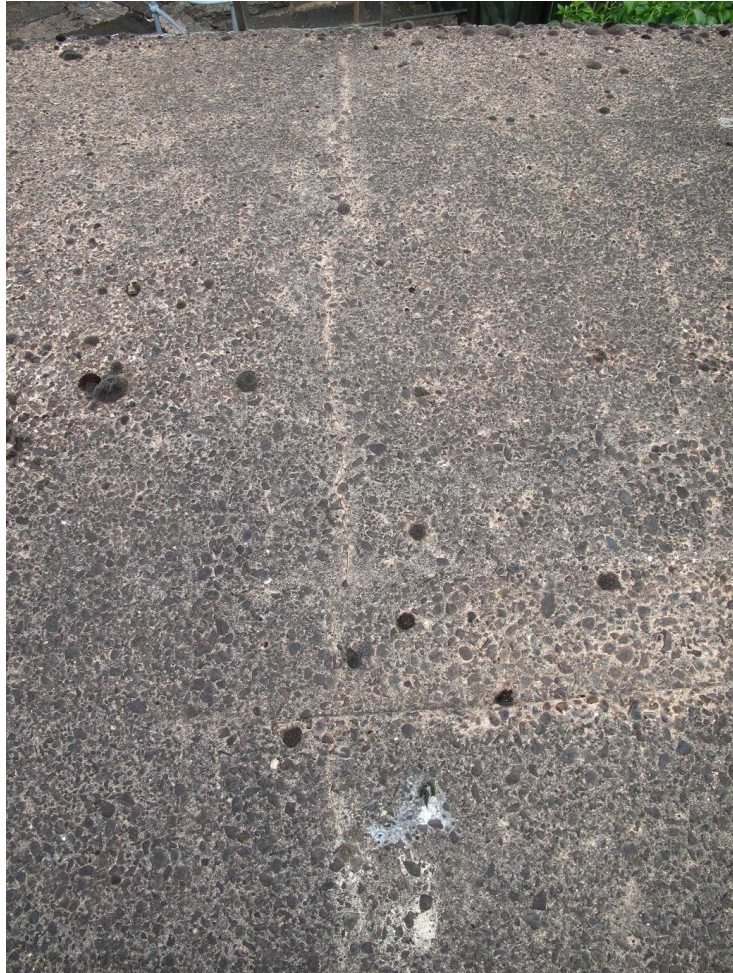
5.1.1 The pattern of some of the longitudinal cracks in the concrete at roof level of the entrance canopy indicates some deflection of the curved slabs. The movement is likely to be historic and there are no signs of significant deformations to indicate that major remedial work is required.

Longitudinal crack in top of roof slab

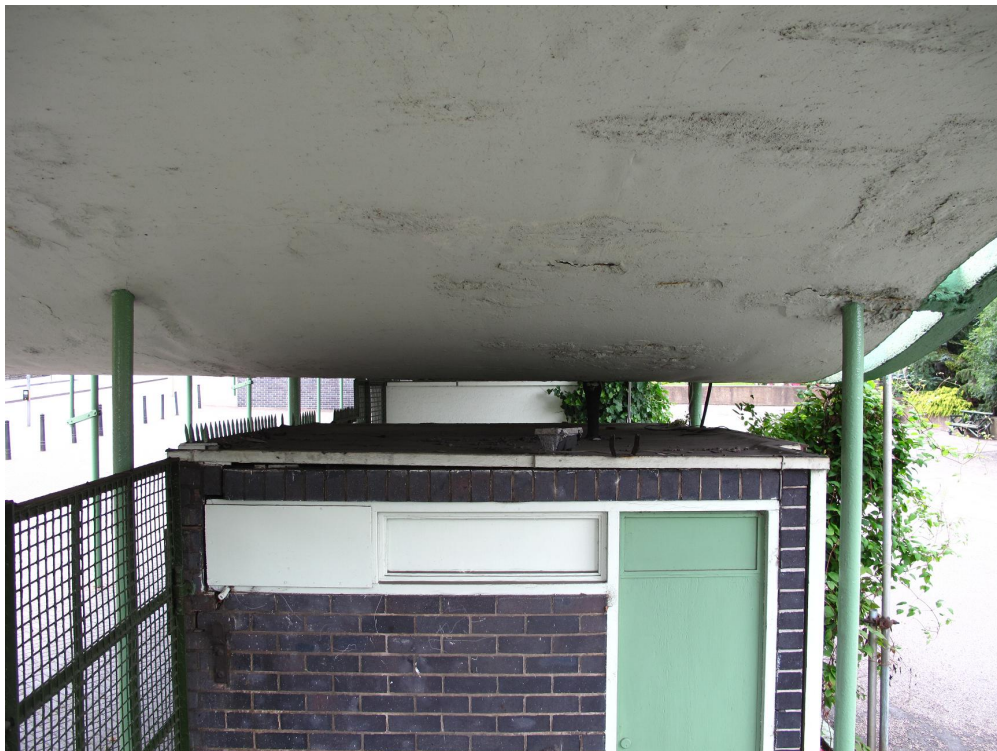
Underside of roof slab

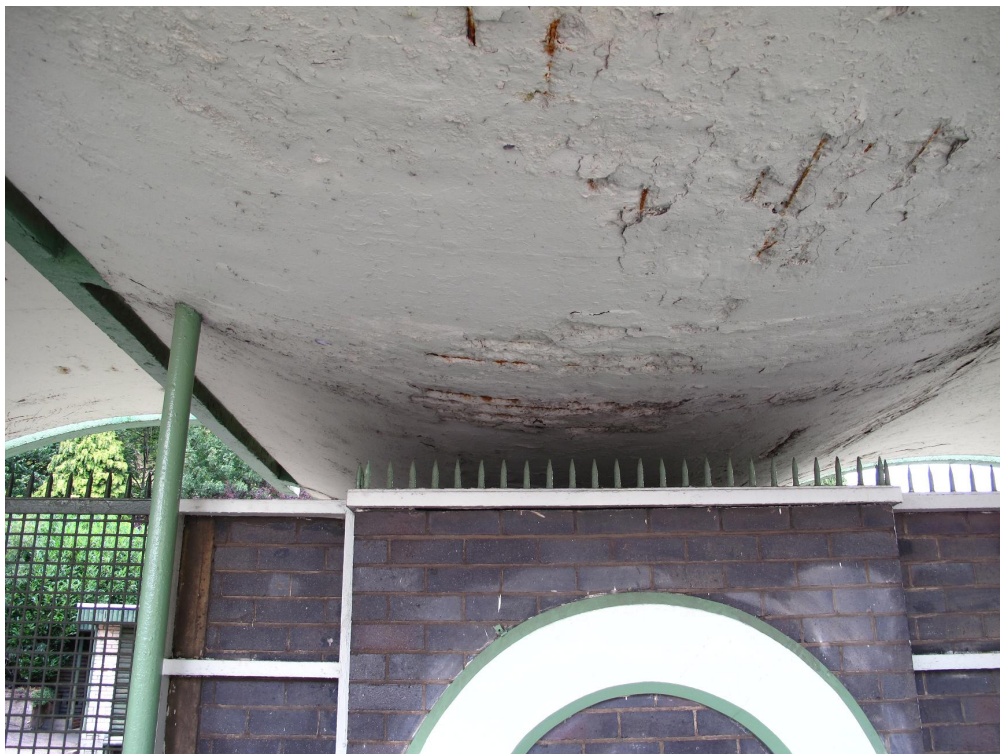
There is extensive corrosion of the reinforcement and spalling of the concrete to the underside of the slabs. Providing temporary support to the reinforcement of the slab in the curved slabs as they were cast in order to maintain adequate cover seems to have been a particular problem and there are areas where the reinforcement is visible on the soffit.

Corroded reinforcement and spalled concrete to underside of roof slab

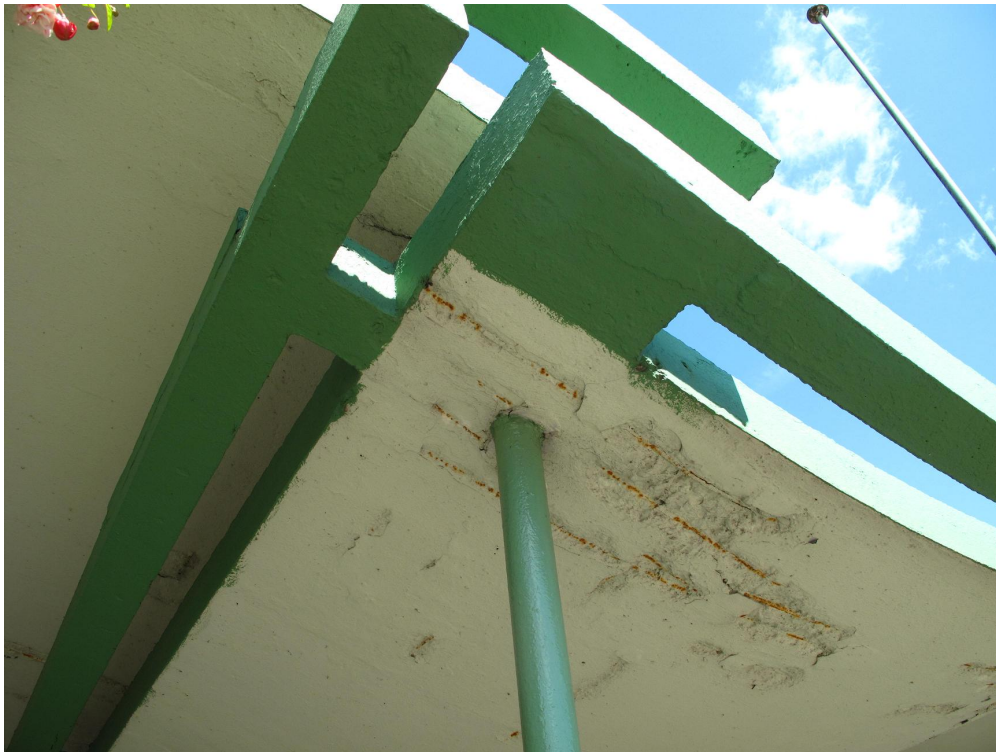
The close centres of reinforcement bars indicate a beam strip in the slab

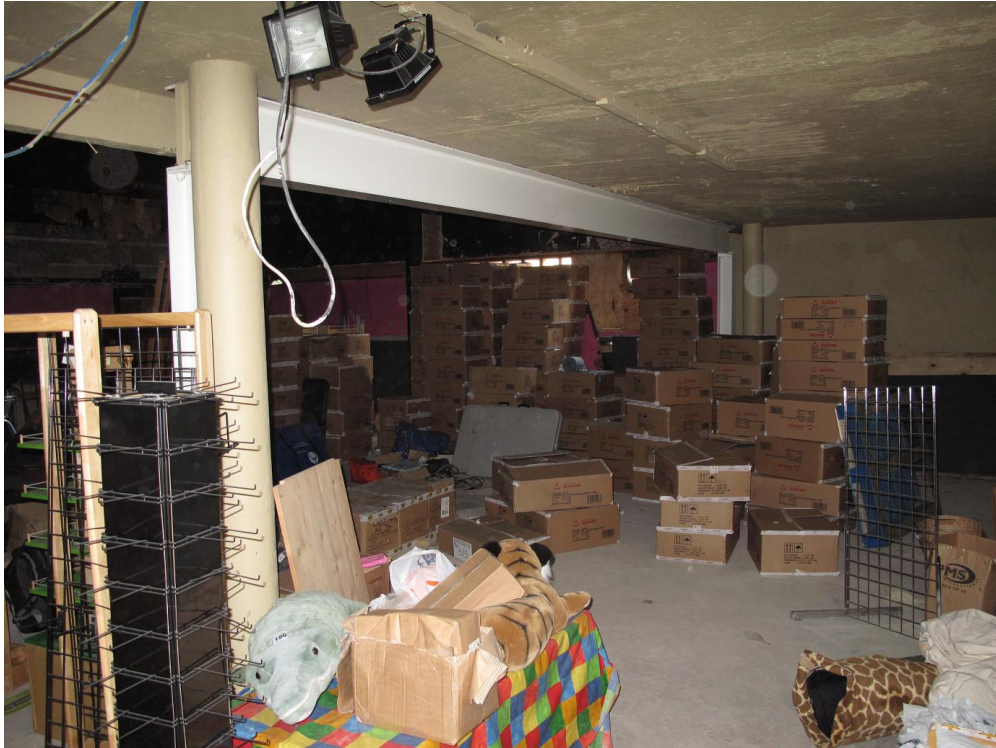
Additional steel beam and columns

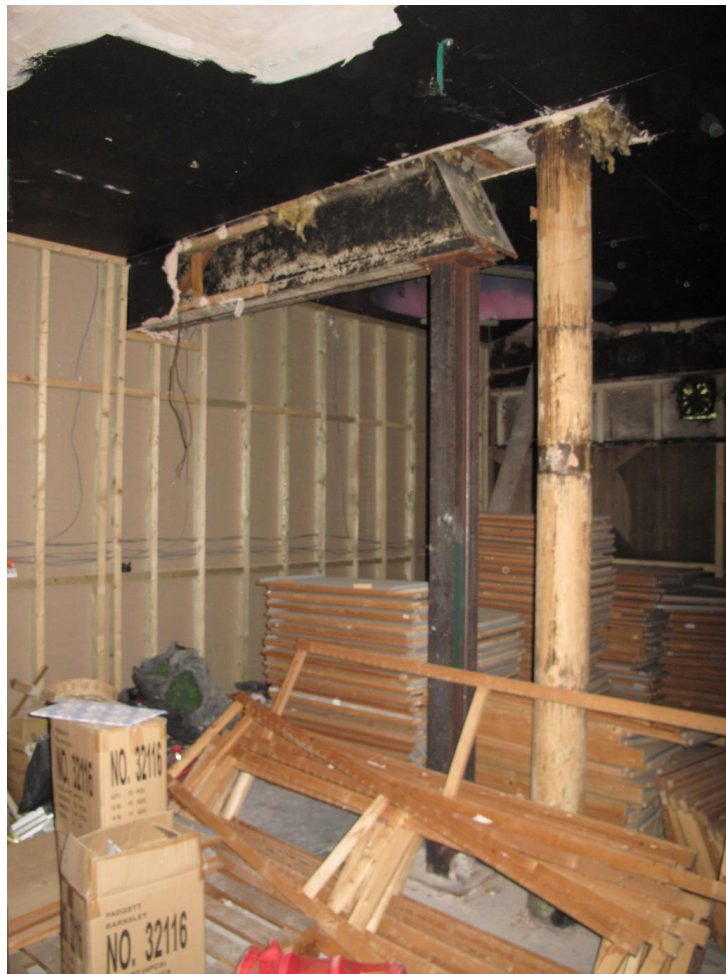
5.2.1 There have been some internal changes to the original structure with the introduction of a steel columns and beam where one of the original columns has been removed. There are no obvious signs of any structural problems as a result of these changes. Repairs of the damaged concrete are proposed and as noted in the Rowan report.

Additional steel frame where a reinforced concrete column has been removed

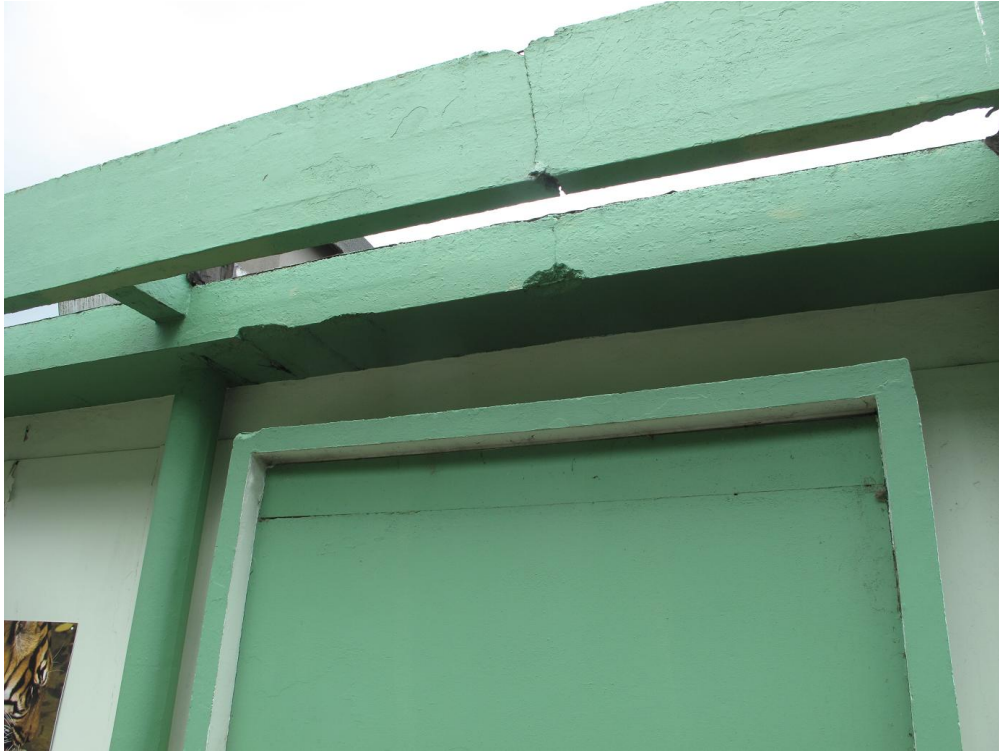
Spalled concrete edge beam at roof level

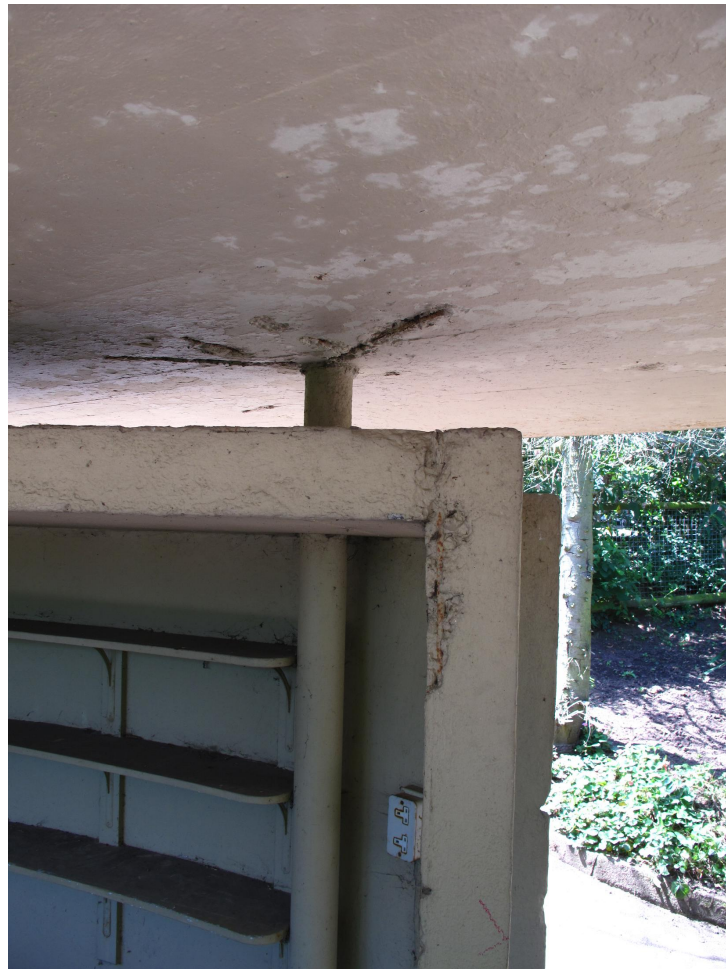
Corrosion to bars in roof slab around top of posts

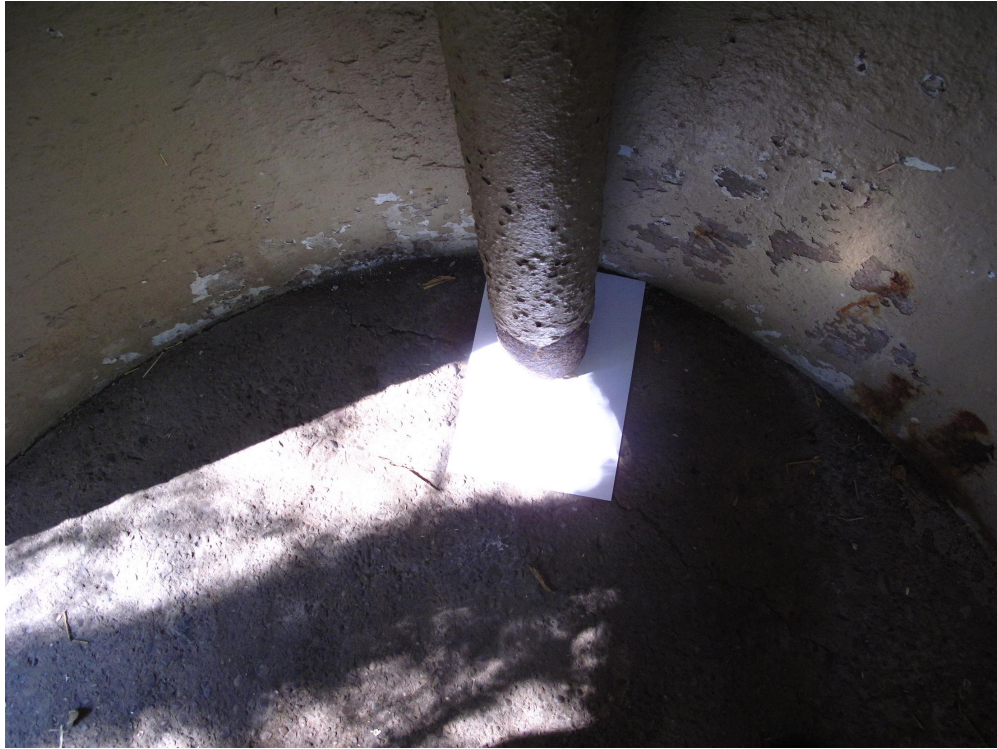
The base to one of the columns has completely corroded and the support is now provided by the encasement of the steel in the reinforced concrete slab at counter level. There is corrosion to the counter and roof slabs and some erosion of concrete to one side of the roof slab.

Base of steel post has completely corroded

- 2.1. A repair is required to the corroded base of one of the circular hollow steel columns. This will involve the local breaking out around the base of the column and the welding of a new circular steel section as shown on drawings K 11 and K 12. All the steelwork will need to be prepared and then coated to prevent further corrosion. General repairs are required to the reinforced concrete structure.

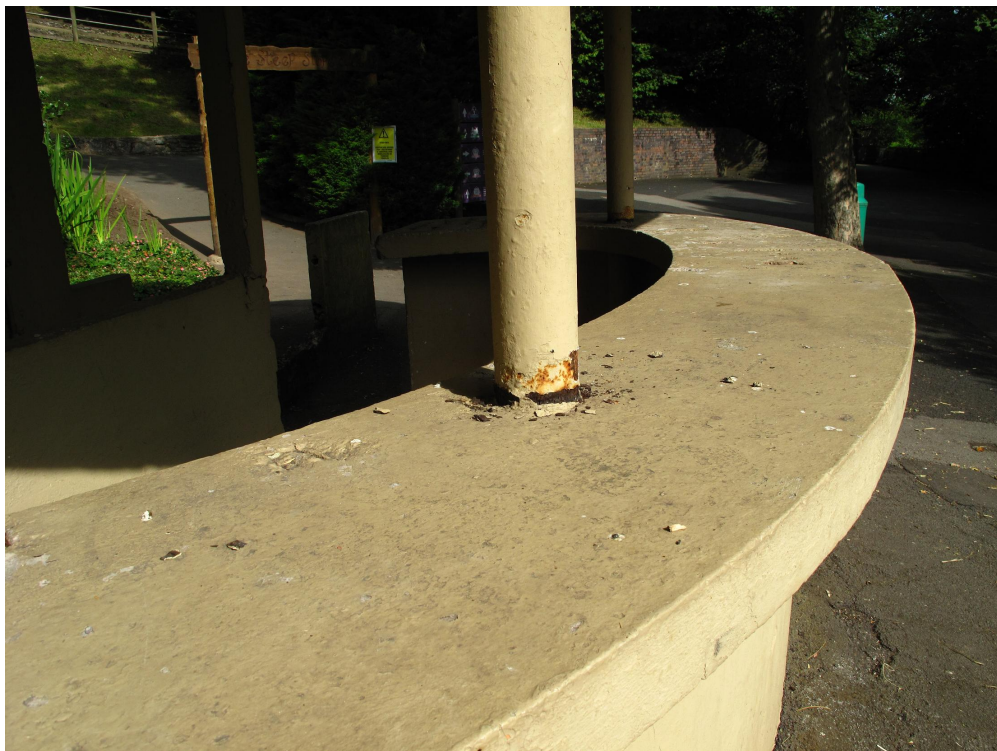
Corrosion to steel post at reinforcement in counter

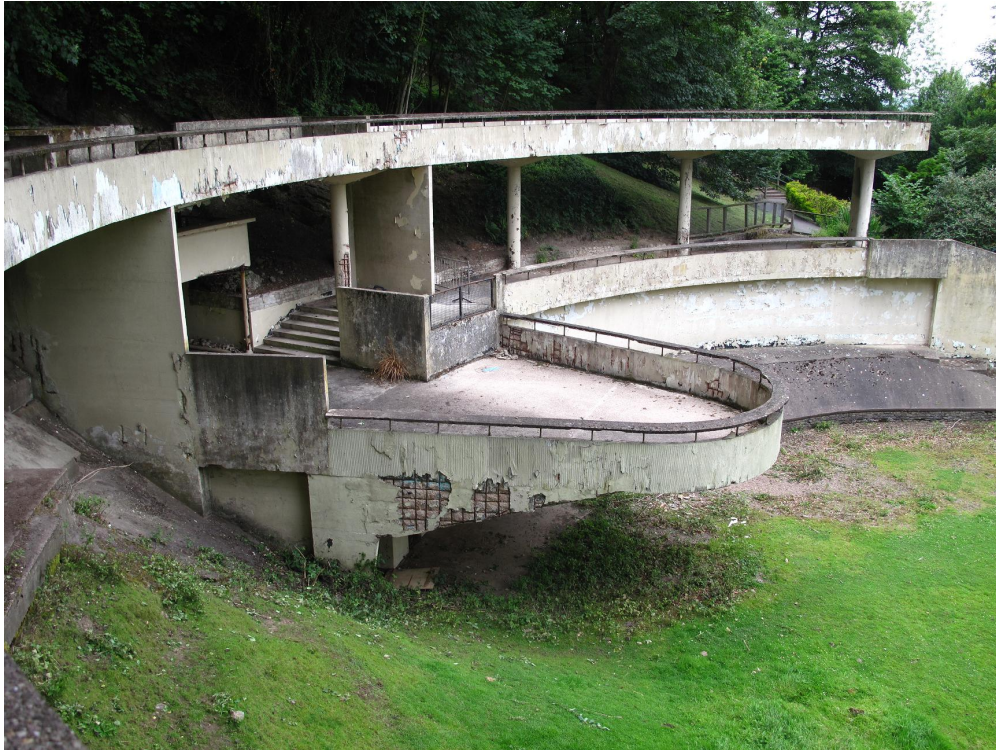
General view showing cantilevered viewing platform

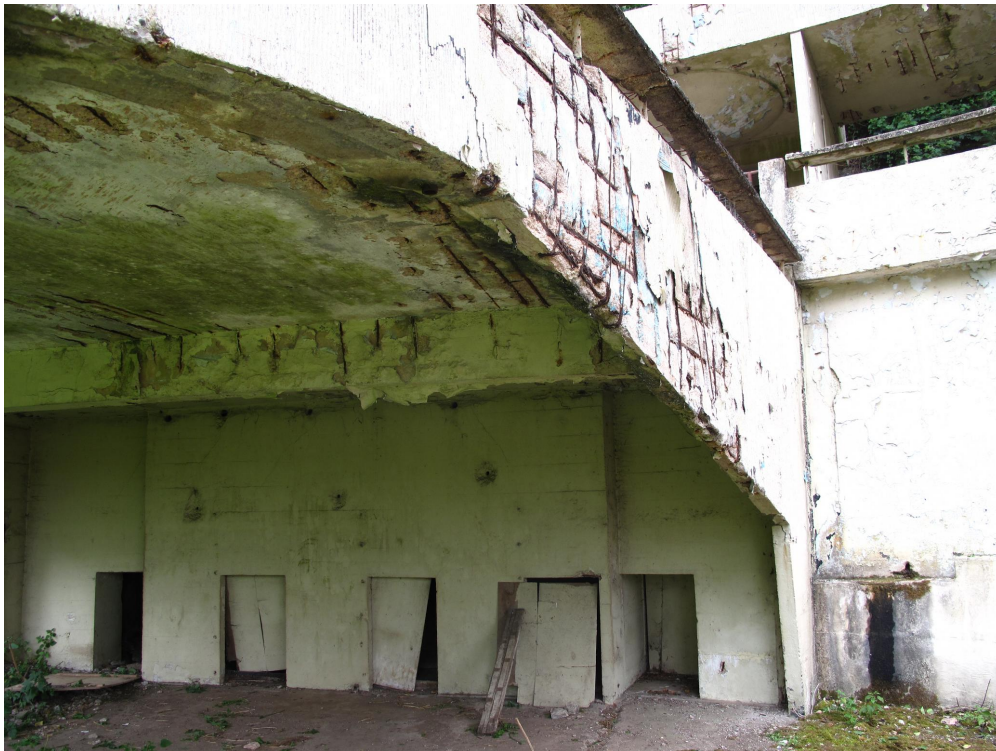
- 3.3. The main item of structural work is to the cantilevered viewing platform. This is in a very poor condition with extensive corrosion and spalling of concrete. The approach here is to deal with the main structural decay issues and add new reinforcement to enhance the performance of the existing structure. It is feasible to carry out these remedial works without any significant change to the visual appearance of the bear ravine.

Extensive corrosion to parapet wall which supports and anchors the cantilevered viewing platform

- 3.5. Structural stiffening is required together with traditional concrete repairs. The structural stiffening will involve the removal of all the damaged concrete and reinforcement to the parapet. New steel reinforcement will be installed which will be anchored to the walls at each side of the balcony. The parapet bars will be tied to new reinforcement added to stiffen the slab. A summary of the proposed works is shown on drawing B 03.

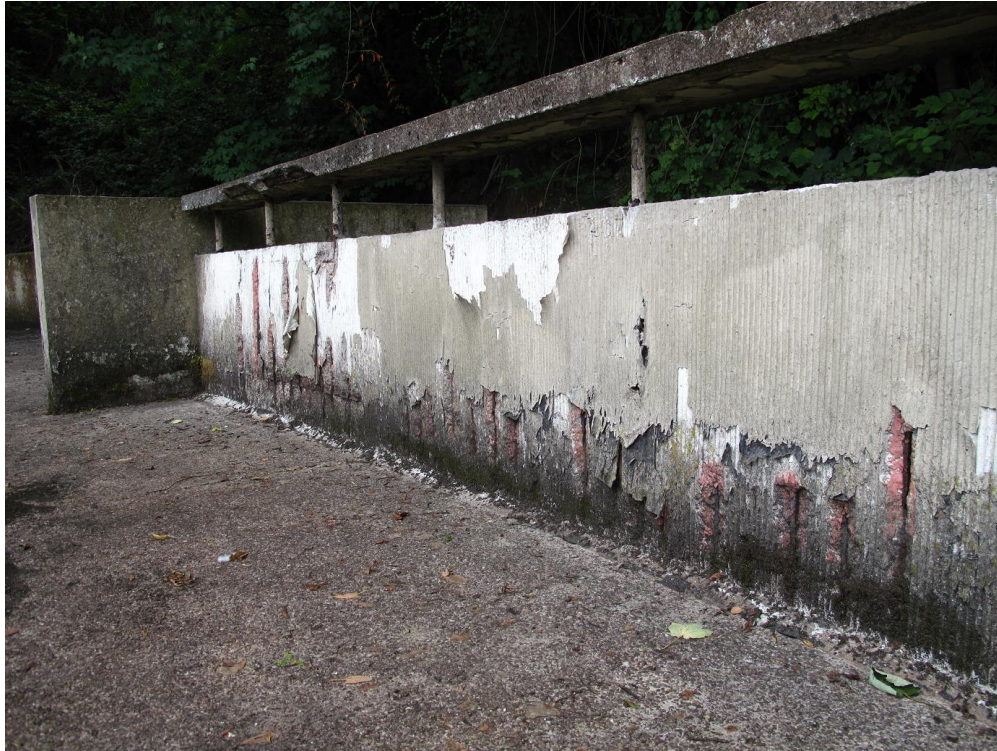
Corrosion to parapet wall to high level walkway

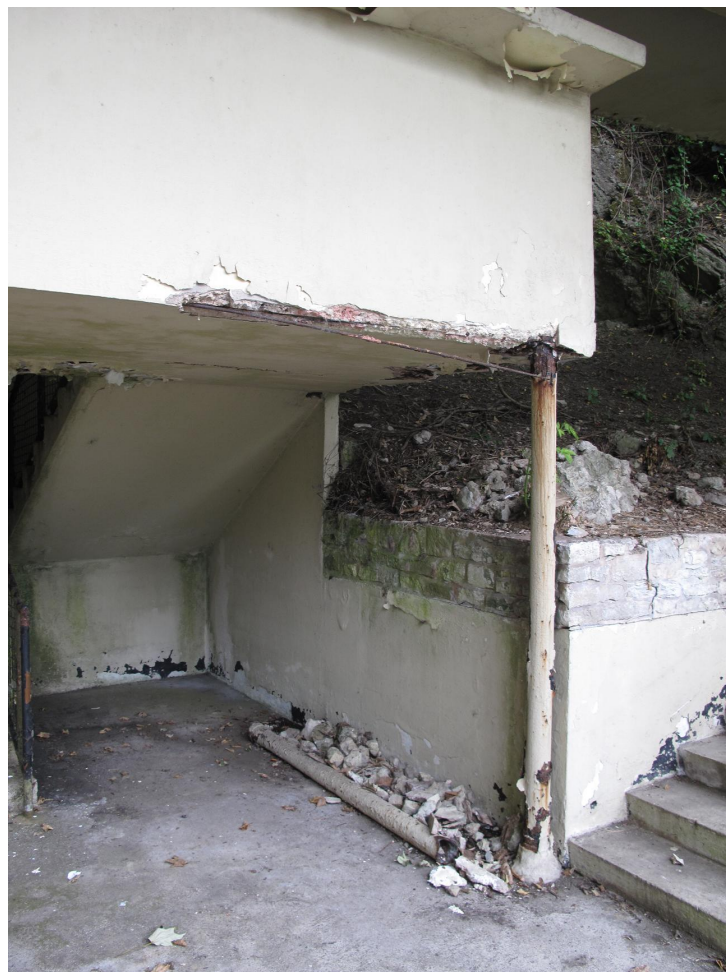
- 3.2. A number of the circular hollow section steel columns are in a very poor condition. Some have previously failed and we issued a drawing for temporary support works which was installed after our first visit. New steel columns to match the existing will be used for the repair.

Failure of steel posts supporting stair landing  
(before temporary support was installed)

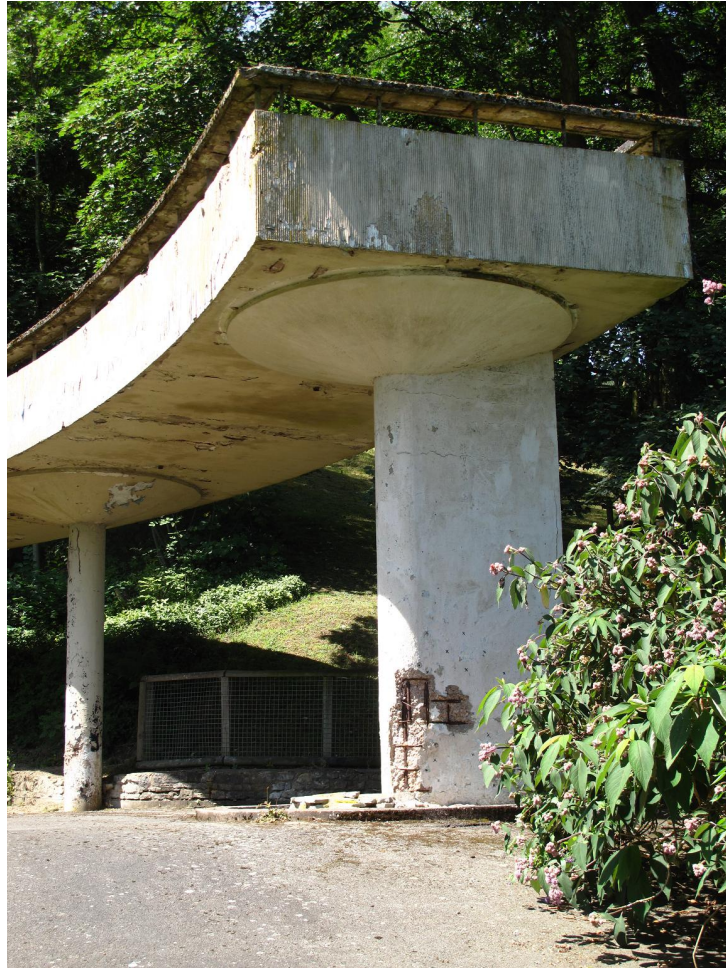
End pier provides vertical support and restraint against lateral loads & Corrosion to end pier

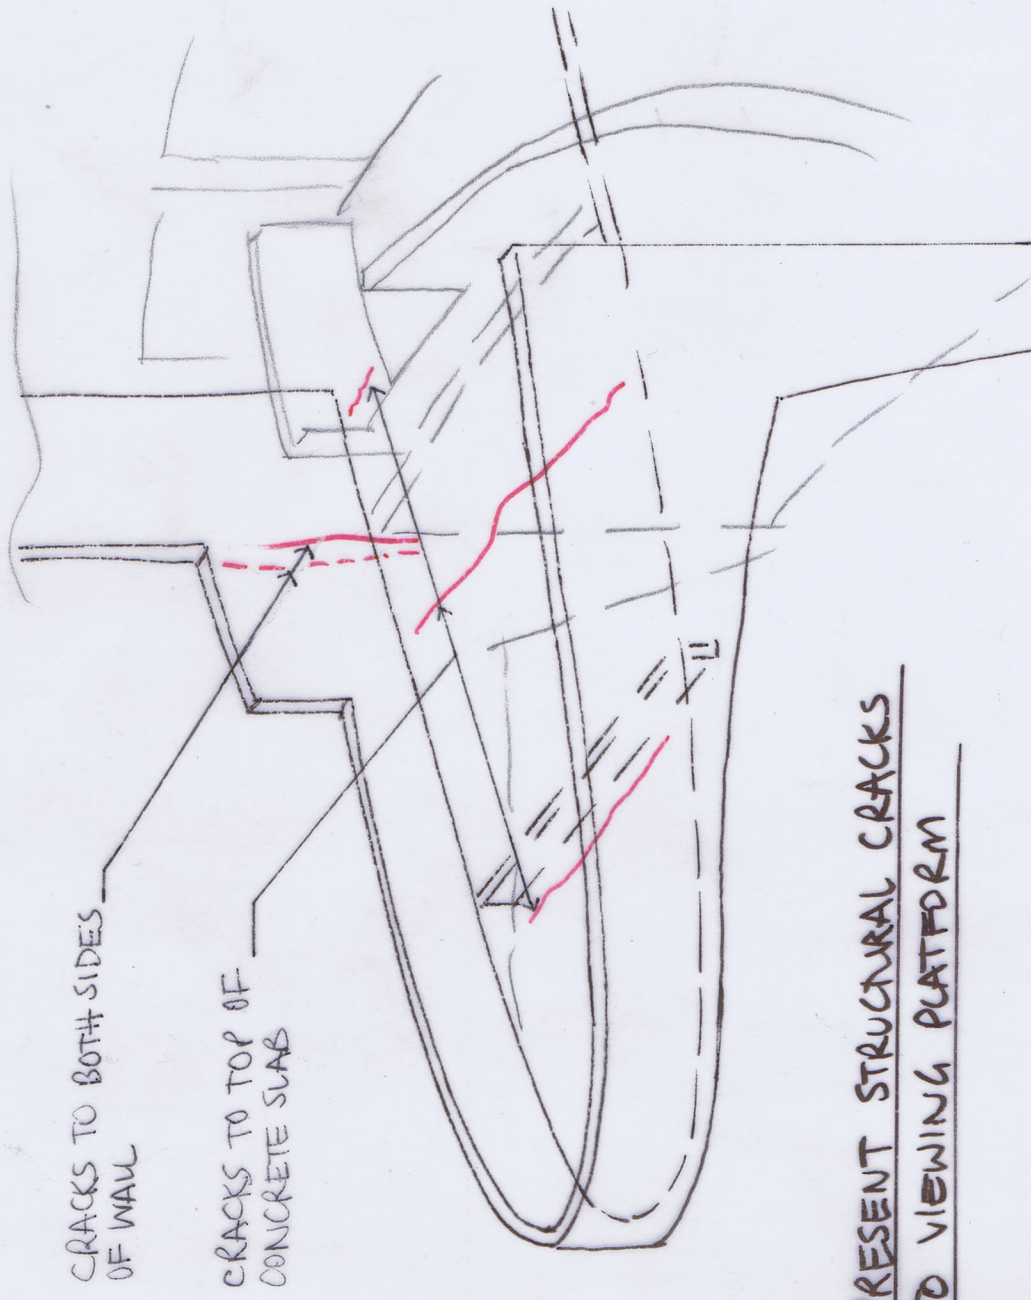
### PRESENT STRUCTURAL CRACKS TO VIEWING PLATFORM

- 3.4. The structure is formed by a thin, approximately 120mm thick, reinforced concrete slab with a 130mm wide reinforced concrete parapet. From the pattern of the cracks it appears that the slab was designed to span between the parapet walls which are then anchored to the main structure. This is summarised on drawing B 02.

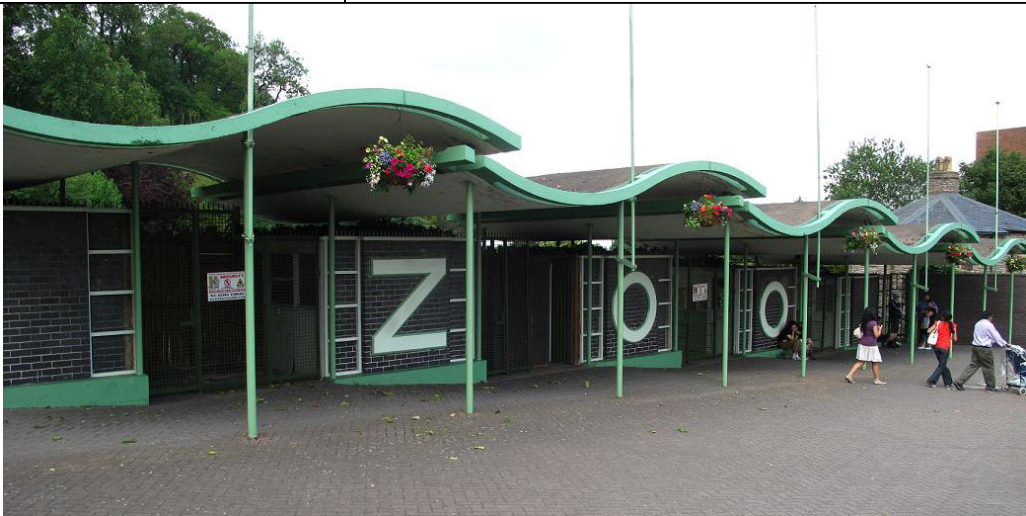
| Comments on the structure: | <ul style="list-style-type: none"> <li>• The masonry structure is in a reasonable condition</li> <li>• There are signs of weathering of finishes to the top of the concrete roof slabs.</li> <li>• There are cracks to the top surface near the centre of each roof slab.</li> <li>• There is corrosion to reinforcement to the underside of the roof slabs. The exposed reinforcements are at close but irregular centres</li> <li>• Corrosion is evident to the base of a number of the steel columns up to 200mm above ground level.</li> </ul> |

| Structural works required: | <ul style="list-style-type: none"> <li>• Corrosion to base of columns; cut back to sound metal and repaired with new steel base onto existing footings and protective coating applied to all columns.</li> <li>• Exposed reinforcement to be cleaned, treated and concrete repaired.</li> <li>• All cracks repaired</li> </ul> |

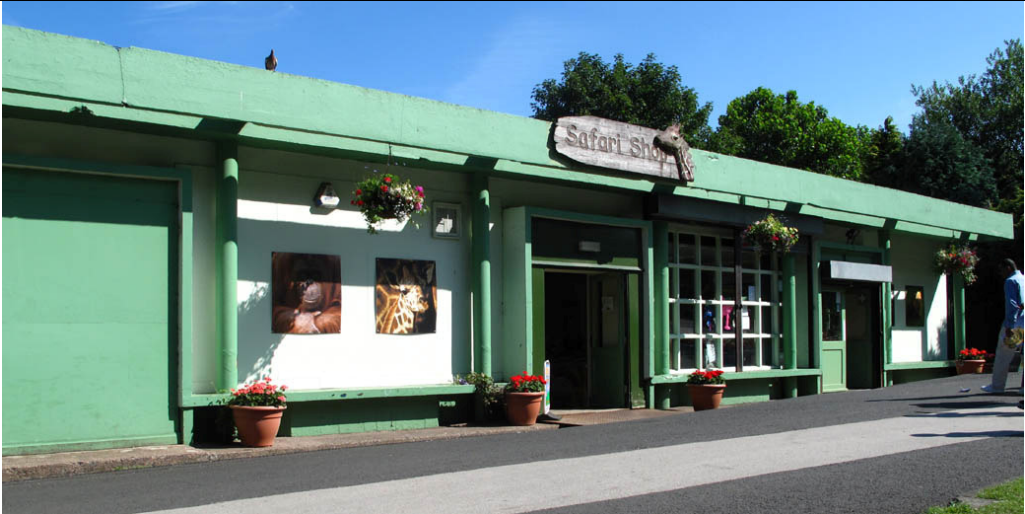
| Comments on the structure: | <ul style="list-style-type: none"> <li>• One RC beam is propped in the store area.</li> <li>• There is a vertical crack in the fascia beam due to shrinkage or thermal movement.</li> </ul> |

| Structural works required: | Corrosion repairs |

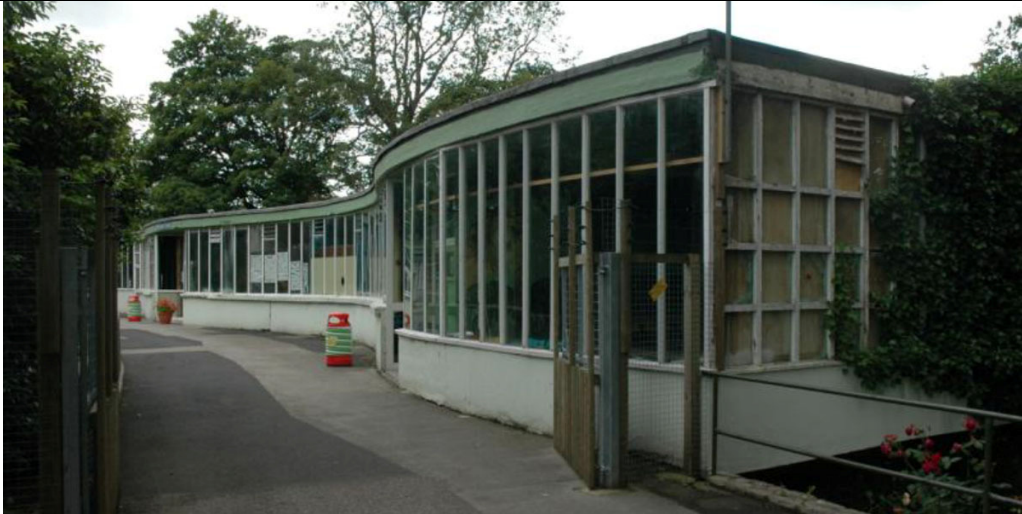
| Comments on the structure: | No visual structure defects to the front or internal area. The rear structure is in poor condition with spalling of concrete to different parts. |

| Investigations required: | <p>Not part of the current works.</p> <p>Extensive investigations are recommended to be carried out by Concrete Specialist.</p> |

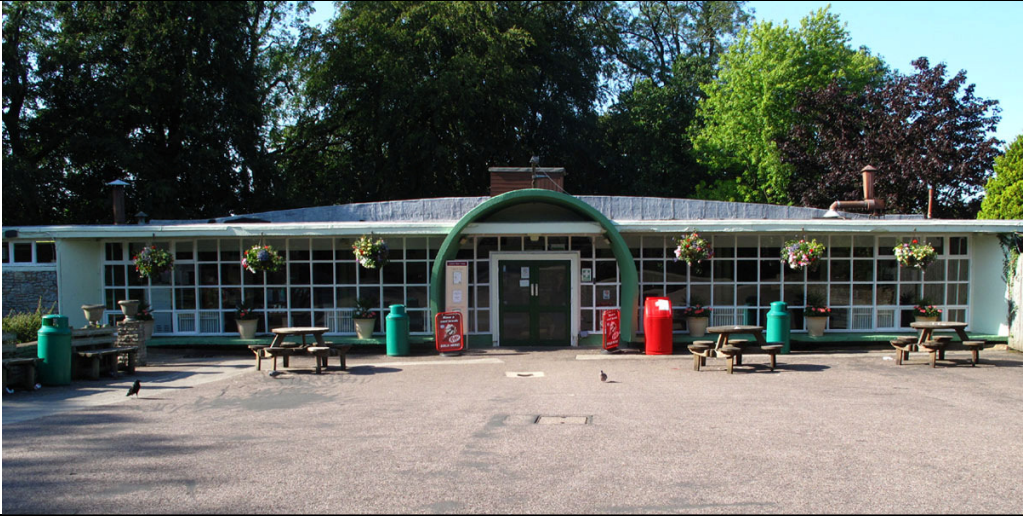
| Comments on the structure: | Some corrosion to the entrance area |

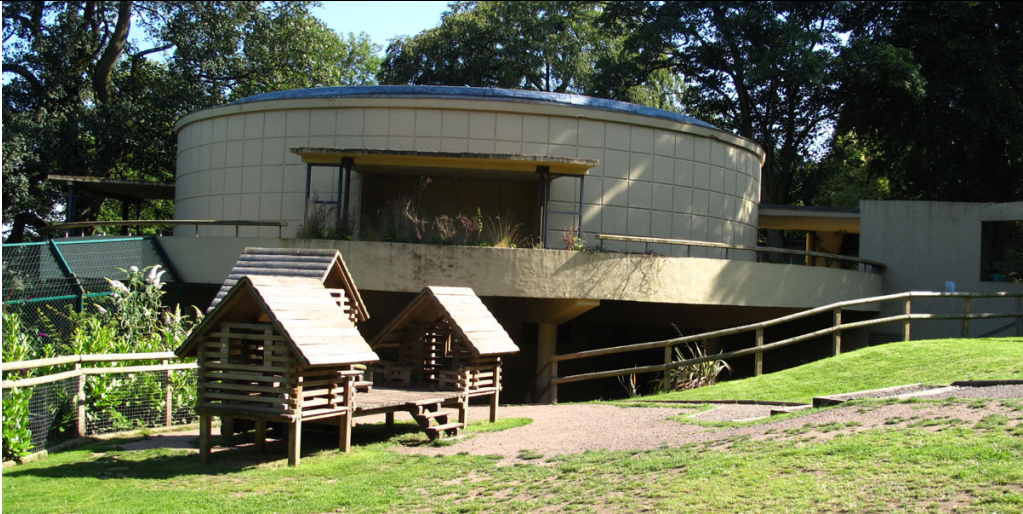
| Comments on the structure: | Some areas of corrosion to steel reinforcement and columns. |

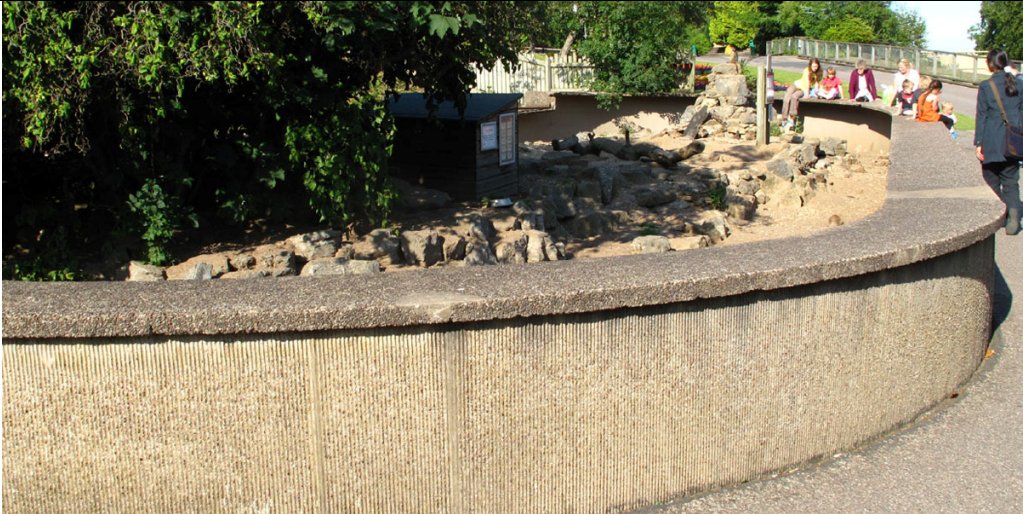
| Comments on the structure: | Parts of the wall around the enclosure are in a poor condition. |
