## TECTON BUILDINGS, DUDLEY ZOO

### Traditional Repair Schemes for Reinforced Concrete Structures

RTL Report No: 1119-01

October 2011

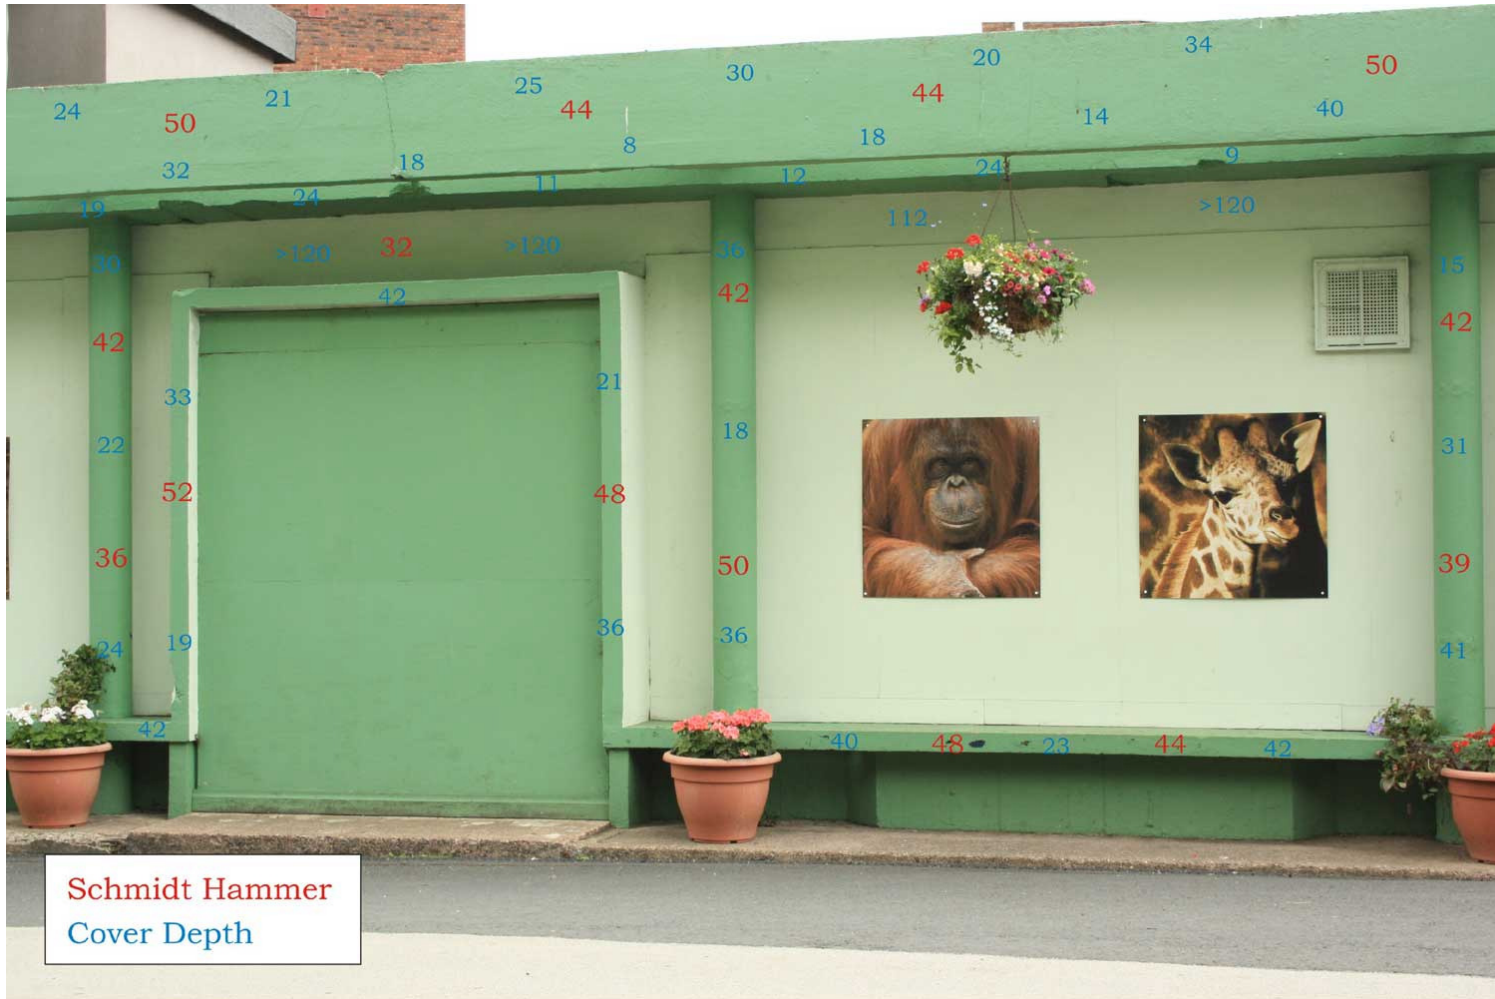
Figure A-19: Right side of the night club building (Area B)

*Station Café* – The left side of the nightclub was assessed for cover and this showed readings of between 16 to 109mm, Figure A-18. The areas of low cover were coincident with delamination and corrosion of the steel reinforcements. The right side of the nightclub showed cover readings of between 8 to 40mm and again delamination was evident in the low cover areas, Figure A-19. The shop was similar in that the concrete cover was between 9 to 46mm and damage was associated with the low cover areas.

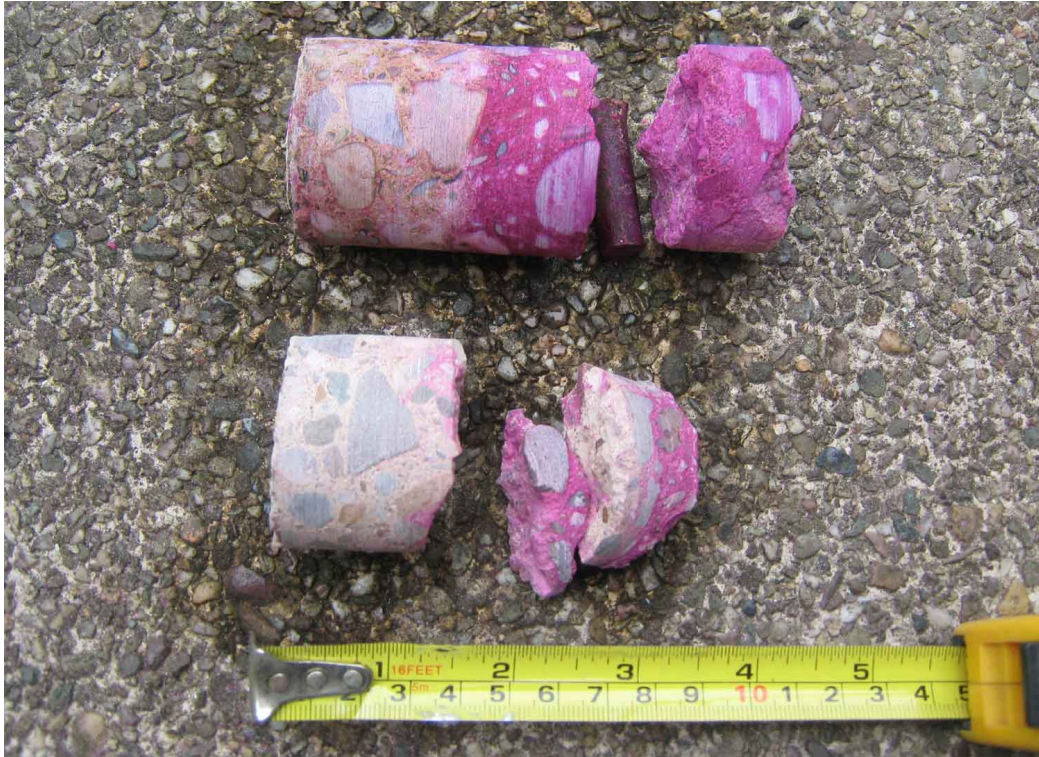
Figure A-21: Carbonation testing of two cores taken from the Bear Ravine.

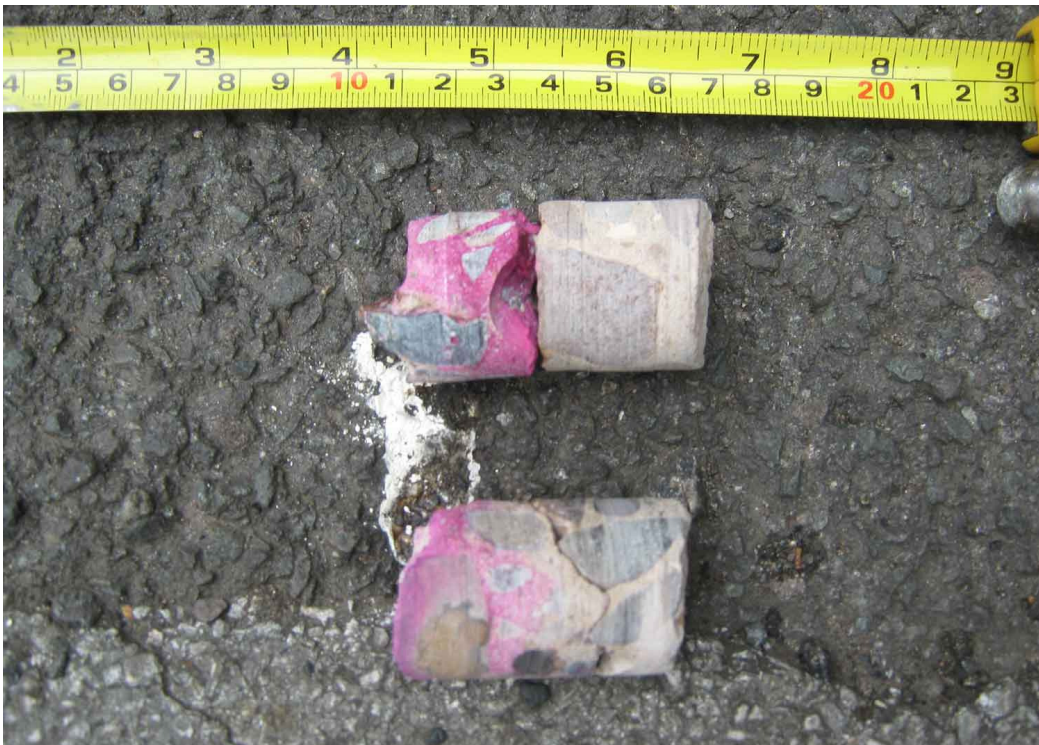
Figure A-22: Carbonation testing of two cores taken from the Kiosk.

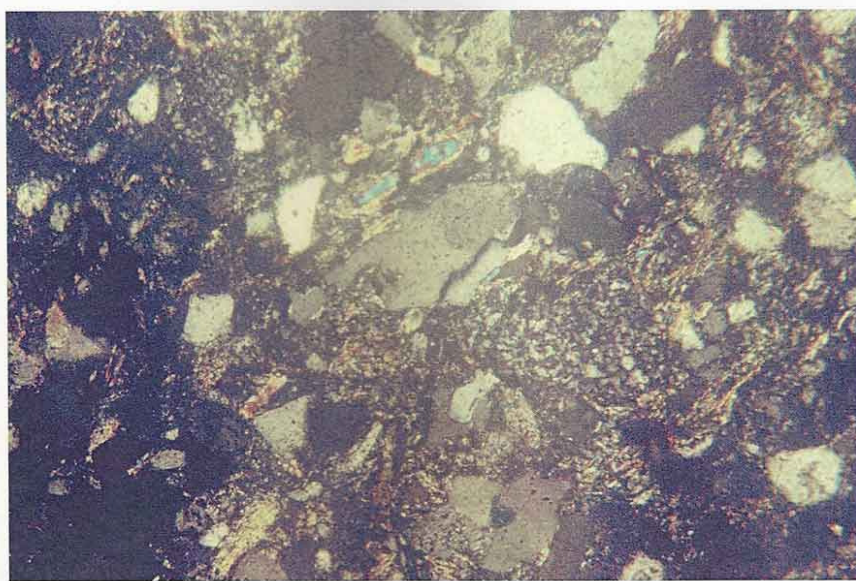
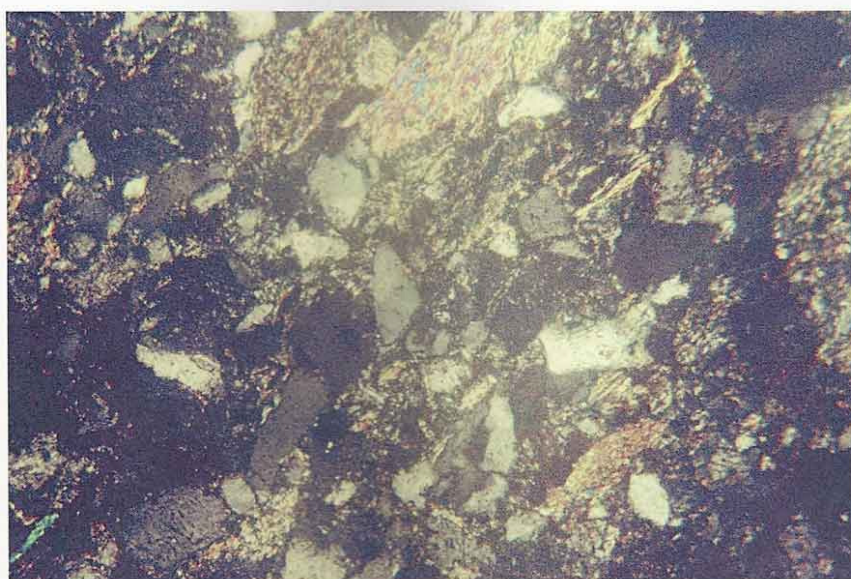
Figure 1 Magnification x140 Crossed Polars

Coarse : Poorly sorted quartzitic conglomerate  
containing particles of mica and chlorite (Figures 1 and 2). The material is typical of a  
greywacke. Also present is moderately well sorted sandstone (Figure 3).

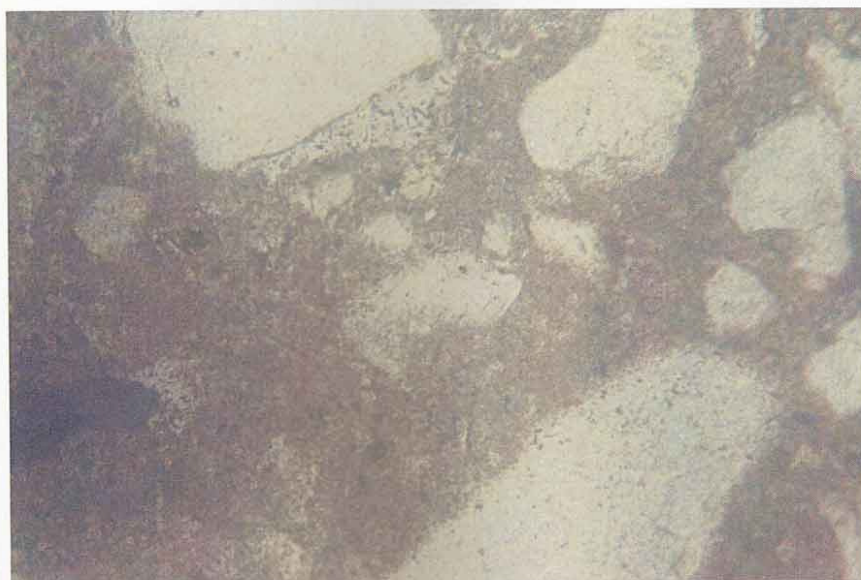
Figure 4 Magnification x140

Fine : Sand containing mainly quartz, but also particles of the coarse aggregate. Figure 4 shows the fine aggregate.

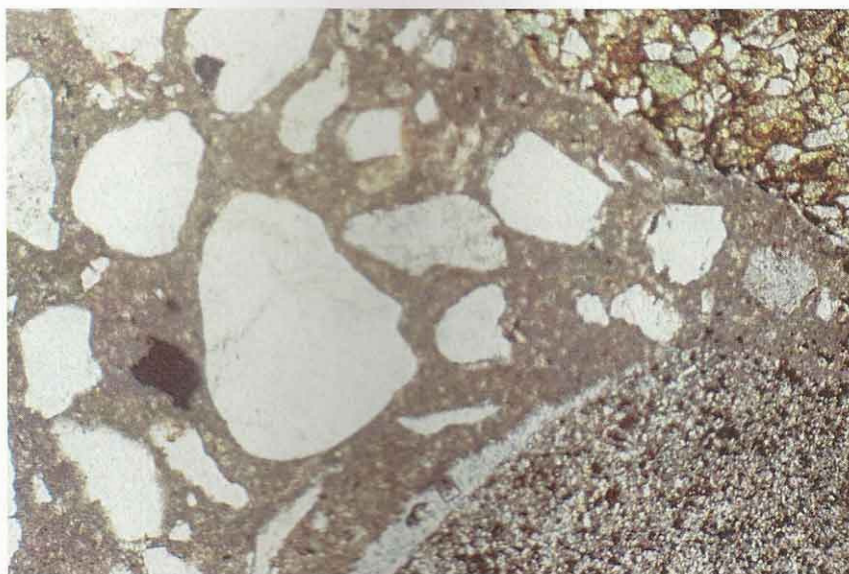
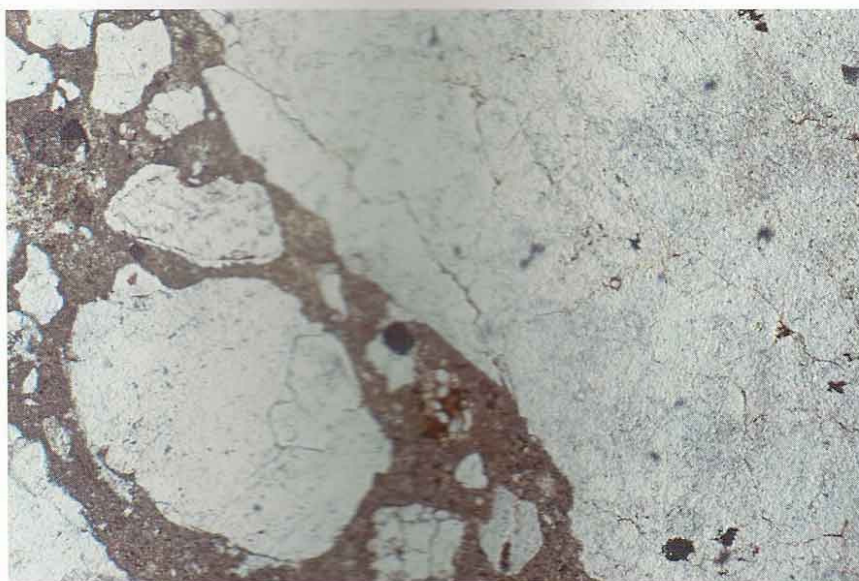
Figure 5 Magnification x60

Cracks : Microcracks are fairly few. These are mostly associated with internal aggregate cracking in both the coarse and fine aggregate, (Figures 5 and 6)
